Urgent Product Correction Notice

This is a follow-up to the previously issued Urgent Product Correction Notice regarding compromised VITEK® 2 card pouches. In regards to the VITEK® 2 Identification / Antimicrobial Susceptibility Test Cards referenced in the previous Urgent Product Correction Notice, three (3) additional card lots have been identified.

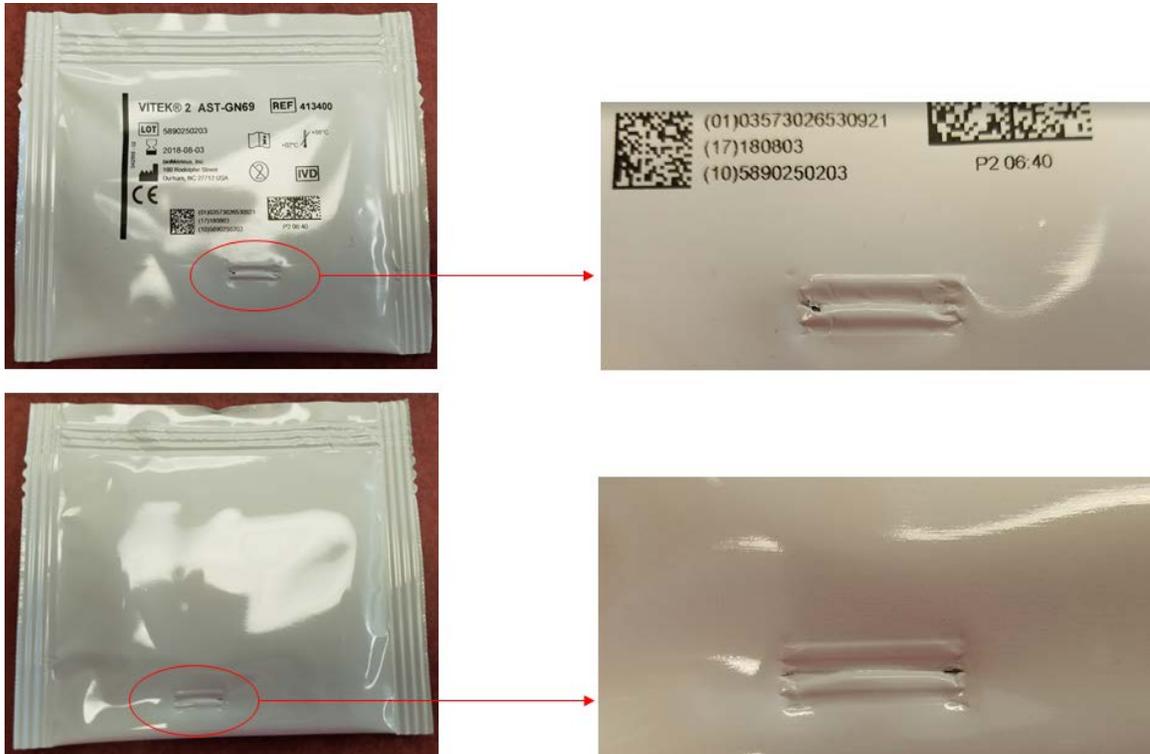
Figure A - Example of Pouch Defect

A potential issue was identified related to the white pouch which contains VITEK® 2 test cards for the referenced product lots. bioMérieux has determined that the integrity of some of the VITEK® 2 test card pouches may be compromised. Based on our investigation, a compromised test card pouch can impact card reagents due to the entry of moisture.

The white pouch is composed of five (5) layers of material, four (4) of which are clear. All five layers must be compromised for a pouch to potentially allow moisture to enter the pouch. Upon visual inspection of the pouch, you may notice a small puncture or tear in the packaging at the "stitch seal" (**see Figure A immediately below**). Per product labeling, do not use the card if the pouch (the white protective package cover) is damaged. Based on internal testing, approximately 20% of card pouches exhibited a visual defect; the majority of card pouches with this visual defect maintained pouch integrity, i.e. at least one of the five material layers remained intact. However, 1 in 200 (0.5%) card pouches that passed careful visual inspection failed further integrity tests, indicating the potential for entry of moisture.

1. Check the lot numbers in your inventory against the referenced lot numbers.
 2. For impacted lots, visually inspect the test card pouches on both sides for the defect.

- a. If the defect is observed, destroy the associated test card(s) and contact your bioMérieux representative for credit or replacement. Until such time as card lots with the new stitch seal become prevalent, there is the potential that replacement cards will include a referenced product lot. In this event, please continue to follow these instructions.

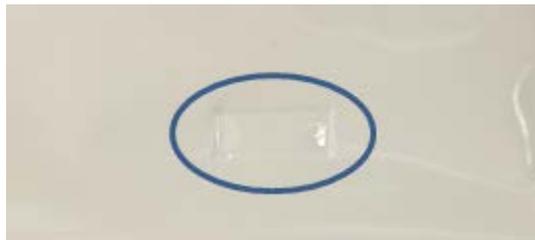
Figure B - New Stitch Seal

The root cause of this issue has been identified and corrective measures have been taken to ensure issues of this type do not affect future Manufacturing lots. Card lots manufactured after March 16, 2017 include a new stitch seal (see Figure B below) and are not affected by the described issue.
