IMPORTANT MEDICAL DEVICE ADVISORY

HeartMate 3™ Left Ventricular Assist System Catalog # 106524INT – LVAS KIT, HM 3 105581INT – Packaged assembly Outflow, HM3(INT)

18. May 2017

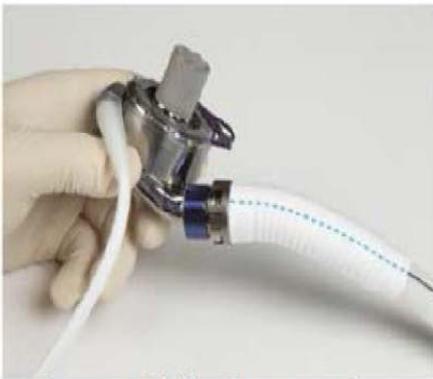
Correct: Fully Connected

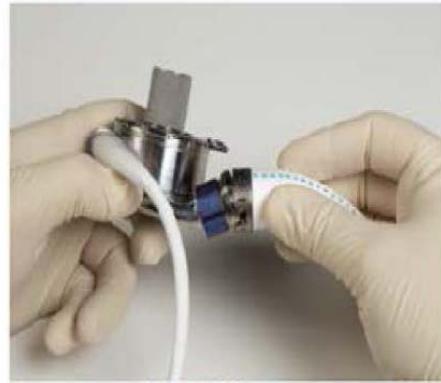
Abbott has observed cases in which the outflow graft bend relief (OGBR) on the HeartMate 3 (HM3) Left Ventricular Assist System (LVAS) was not fully and evenly secured to the outflow graft. As a result, we conducted an internal review of x-rays from both the U.S. MOMENTUM 3 IDE and Continuous Access Protocol (CAP) studies, and identified additional cases where the OGBR was not properly secured.

There may be no symptoms associated with an OGBR that is not fully and evenly connected; however, there is potential: (1) for kinking of the outflow graft leading to a low flow state that may result in heart failure symptoms and reoperation; or (2) for mechanical wear and tear of the outflow graft leading to intra-pericardial bleeding potentially causing hemodynamic compromise that may require emergency surgery.

Incorrect: Not Fully Connected

- For patients already implanted with the HM3 LVAS, please review a current x-ray to ensure the OGBR is fully and evenly secured to the outflow graft. Where images of the outflow graft and bend relief are not available, please take images at the patient's next visit and review to ensure the OGBR is properly secured.

- For newly implanted patients, please take an x-ray one day post-implant and review it to ensure the OGBR is fully and evenly secured.

- If a disconnected OGBR is identified during x-ray review, physicians should determine patient care recommendations based on each unique clinical case. Additionally, review with your Abbott clinical specialist to file a complaint through the normal complaint process.
