Update to Medical Device Correction
Philips M1783A/M5526A Sync Cables & 989803195641 ECG Out Cables
Electrical Interference Could Pose a Risk to Patients

URGENT - Medical Device Correction
Philips M1783A/M5526A Sync Cables & 989803195641 ECG Out Cables
Electrical Interference Could Pose a Risk to Patients

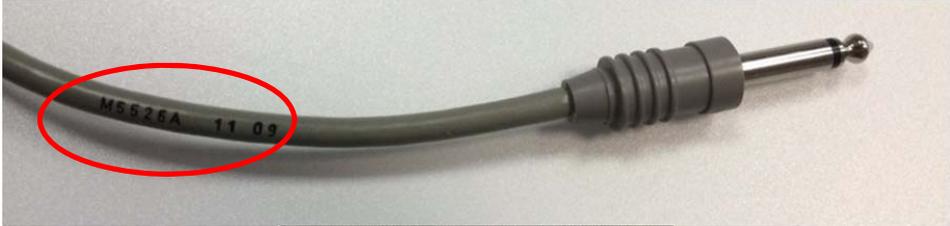
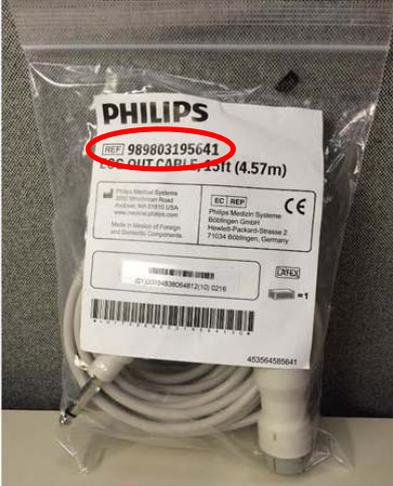
| <p>HOW TO IDENTIFY AFFECTED PRODUCTS</p> | <p>Philips M1783A/M5526A sync cables and 989803195641 ECG out cable identified above are affected by this issue.</p> <p>The model numbers are printed on the outside of the cable, near the end with the ¼" phone plug and on the bag label.</p> <div style="text-align: center;"> </div> |

| <p>ACTION TO BE TAKEN BY CUSTOMER / USER</p> | <p>Customers should remove affected sync cables and ECG out cables from service and destroy them, documenting such action on the attached reply form, which should be returned to Philips. Customers should retain a copy of the reply form.</p> <p>The customer should follow the Instructions for Use that describe the recommended approach for performing cardioversion with the XL+ and MRx monitor/defibrillators. The ECG trunk cable can be disconnected from the Philips bedside monitor and connected to the monitor/defibrillator before delivering therapy; this is the preferred source of an ECG waveform for synchronization.</p> |
