FIELD SAFETY NOTICE (FSN)

It has come to our attention that Sysmex haematology IVD analyser

XN-550

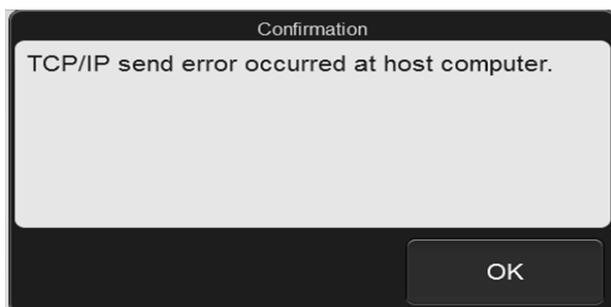
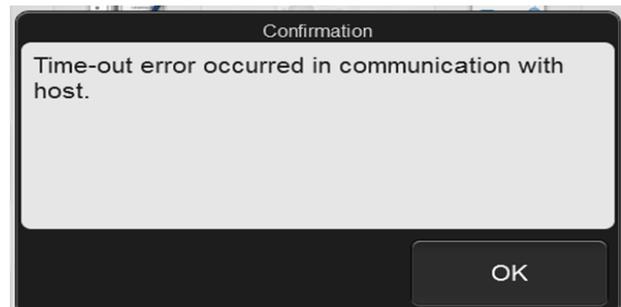
- In case a host communication error appears during XN-550 sampler analysis, it results in an error message and the sampler stops.
- If at that time a sample tube is located in the sample tube holder, it will not be processed until the error is accepted. The time between appearance and acceptance of the error can vary depending on the attendance of the analyser. During this time sedimentation of the blood sample will occur.
- After accepting the error the sample tube might be processed without additional mixing, which could lead to potentially wrong measurement results due to blood cell sedimentation.

Examples of possible error messages of the XN-550 which would indicate erroneous communication with the host.

In case an error message related to host communication and/ or TCP/IP connection appears during an XN-550 sampler run due to a host communication failure, it is MANDATORY to check the sample tube holder and remove the sample tube, if possible, BEFORE accepting the error and restarting the sampler. In case the sample tube holder is not accessible, accept the error message and do NOT use the measurement result from this particular measurement. Make sure the sample is re-analysed. Otherwise there is a risk for aspiration without prior mixing, leading to wrong measurement results.
