Urgent Field Safety Notice

SBN-CPS-2017-015

CPS / Serum Work Area
Version 1
11-Jul-2017

cobas c 501/502 operator injury on USM cover 3

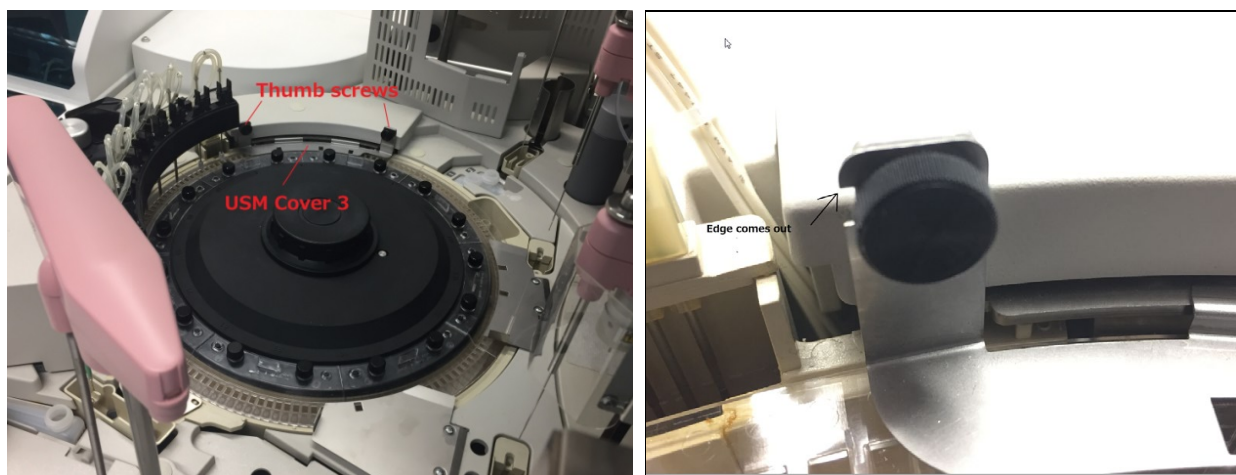
1. The operator was performing monthly maintenance to clean the incubation bath and replace cuvettes on a **cobas c** 502 module.
2. As a preparation step, thumb screws were being loosened to remove the USM cover 3, as illustrated below.
3. When the operator gripped the left thumb screw and tried to loosen it, she felt pain on her left thumb and found that it was already bleeding.
4. Her thumb was injured by the 90 degree-edge of the USM Cover 3, which is shown on the following picture.

Although the sharp edge of the USM Cover 3 is clearly visible, a medical risk due to an injury cannot be excluded.

A warning will be added to the respective Operator Manuals, which will be available by December 2017.

Customers are advised not to overtighten the thumb screws when replacing the cover after maintenance. When removing the screws for maintenance **avoid** touching the edge of the USM Cover 3.
