## Urgent Field Safety Notice

### SynchroMed® II Implantable Drug Infusion Pump

Design Change of Model Numbers 8637-20 and 8637-40

Medtronic reference: FA794

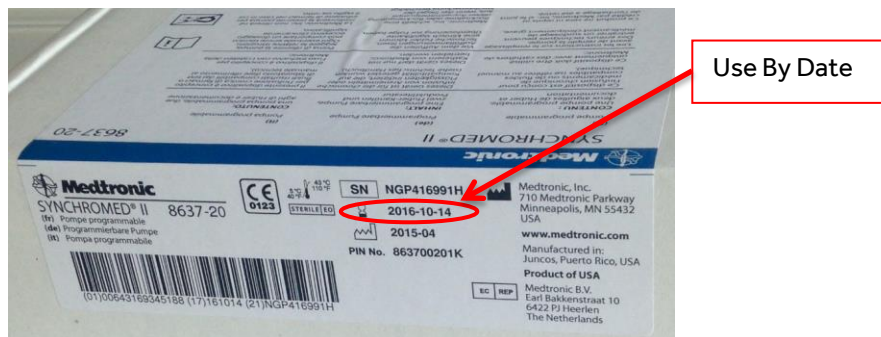
**Pump Identification:** in Europe, Middle East, Africa, Latin America and India any pump with a Use By Date **on or before** 2018-12-31 was manufactured **prior to** design change. An image of the Shelf Box Side Label of the SynchroMed II is shown below.
