Urgent Field Safety Notice

Potential for Shortened RRT-to-EOS

Subset of the following devices:
Claria MRI™/Amplia MRI™/Compia MRI™/Viva™/Brava™ CRT-Ds Visia AF™/Visia AF MRI™/Evera™/Evera MRI™ ICDs

Medtronic Reference: FA951

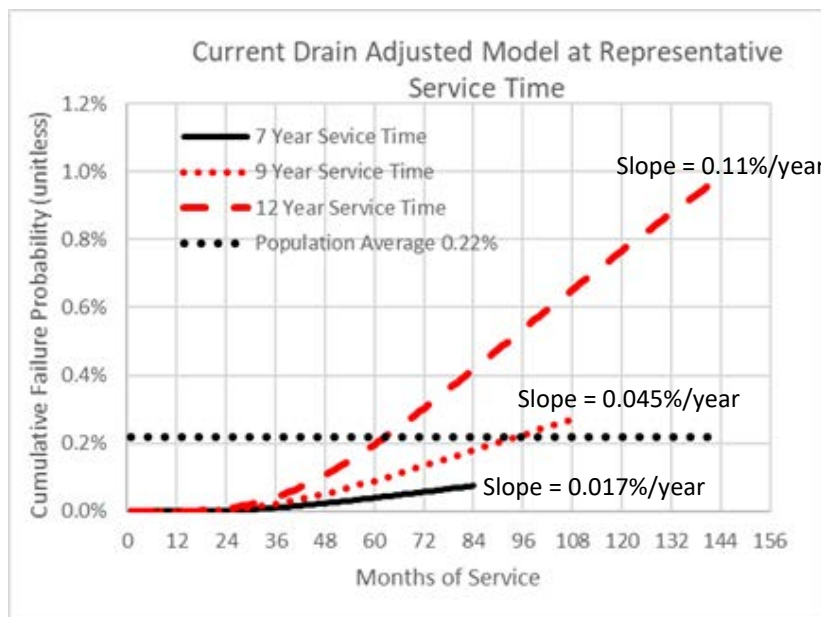
Probability (Risk per Year) of Rapid Depletion due to this Issue as a Function of Service Time

Cumulative Probability is the expected risk for a device to experience this issue between implant and end of service. When risk is evaluated for a device that has reached a service life beyond 3 years, the remaining risk can be estimated based on the yearly risk value shown.

The Population Average (0.22%) is the cumulative probability for the full subset of devices susceptible to this issue. This value takes into account expected longevity and patient mortality. Not all devices with projected service time of 12 years will be in service all 12 years.

Key Points:
Slope of the curve reflects the risk per year based on sample service times of 7, 9, and 12 years.

Slope (risk per year) is constant after approximately 3 years of service time.
