Urgent Field Safety Notice
Product Correction
Urgent - Immediate Action Required

March 7, 2019

Alinity ci-series issues resolved in software version 2.6.0

Alinity ci-series hardware issues resolved

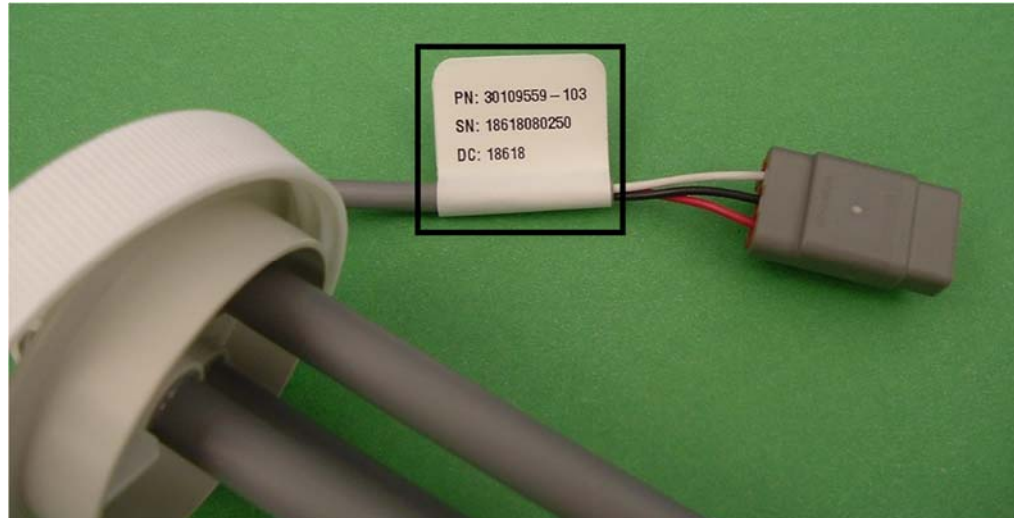
Figure 1. Level Sensor, Bulk Solution identification label

Abbott has identified an issue with the Alinity ci-series Level Sensor, Bulk Solution (LN 04S68-01), resulting in the failure to detect the depletion of a bulk solution reservoir. This issue leads either to a failure to dispense the bulk solution or an incomplete dispense of the bulk solution which affects the Alinity i-series and Alinity c-series differently (see details in **Appendix B**).

- If the part is in the box, the list number (04S68-01 or 04S68-02) is printed on the label
- If the part is removed from the box or installed on the Alinity ci series, the part number is printed on a label attached to the electrical connection for the part. See Figure 1 and Table 1 below.

- a. If LN 04S68-01 Level Sensor, Bulk Solution is installed in the Alinity i Trigger or Pre-Trigger bulk solution reservoirs, Abbott recommends these sensors be replaced with a Level Sensor, Bulk Solution, LN 04S68-02 before further test processing is performed.

- b. Abbott recommends all LN 04S68-01 Level Sensor, Bulk Solution installed in the following bulk solution reservoirs be replaced with a Level Sensor, Bulk Solution, LN 04S68-02. However, you may continue to run the system until replacement parts are obtained as a level sensor failure in these bulk solution reservoirs would not impact results:

List Number (LN)	Part Number (PN)	Instructions
04S68-01	30109559-102	Remove and replace any Level Sensor, Bulk Solution, LN 04S68-
04S68-02	30109559-103	01/PN 30109559-102 with LN 04S68-02/PN 30109559-103
