Urgent Field Safety Notice

CFx Longevity Estimator Software Error

October 2019

Medtronic Reference: FA887

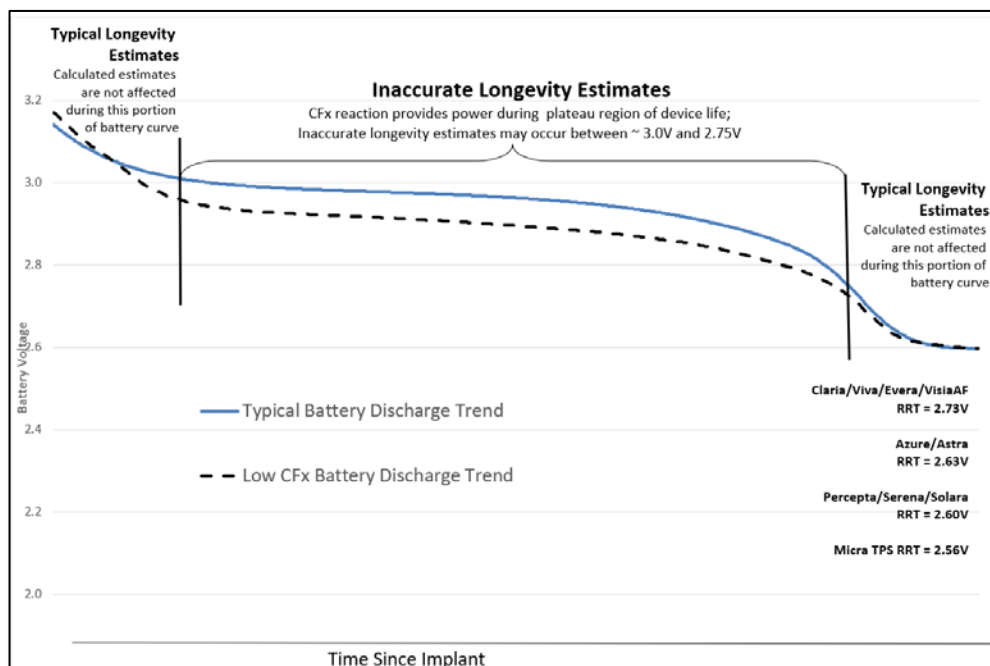
The inaccurate longevity estimation is limited to a well-defined subset of devices manufactured between October 2018 and April 2019, and only occurs in the middle (plateau) phase of the device life, as illustrated in the graph below. Approximately 53,100 devices worldwide, out of 1.23 million distributed or sold from the identified device families, are susceptible to displaying inaccurate longevity.

The cause of the inaccurate longevity estimate is a slightly lower-than-typical discharge voltage during the plateau phase of the battery depletion curve (dashed line), compared to a typical voltage plateau (solid line), as illustrated in the graph below. During this plateau period, the Carbon Monofluoride (CFx) in the battery cathode is powering the device. Note, longevity estimates early after implantation and later in the device life are unaffected, as shown below. The battery remains within operating specifications.

Software updates to programmers and remote monitoring systems are under development to correct for the inaccuracy in longevity estimates. Medtronic is targeting regulatory approval and release of the software updates to begin in mid-2020. Once available, Medtronic will inform you of the availability of the software and work with you to install the software onto clinic and hospital programmers. Software updates to individual patient devices will not be necessary to correct this issue, since longevity estimation resides on the programmers, mobile app and the CareLink Network
