URGENT Field Safety Notice

EPIQ CVxi Diagnostic Ultrasound Systems
EchoNavigator System Error

13-SEP-2021

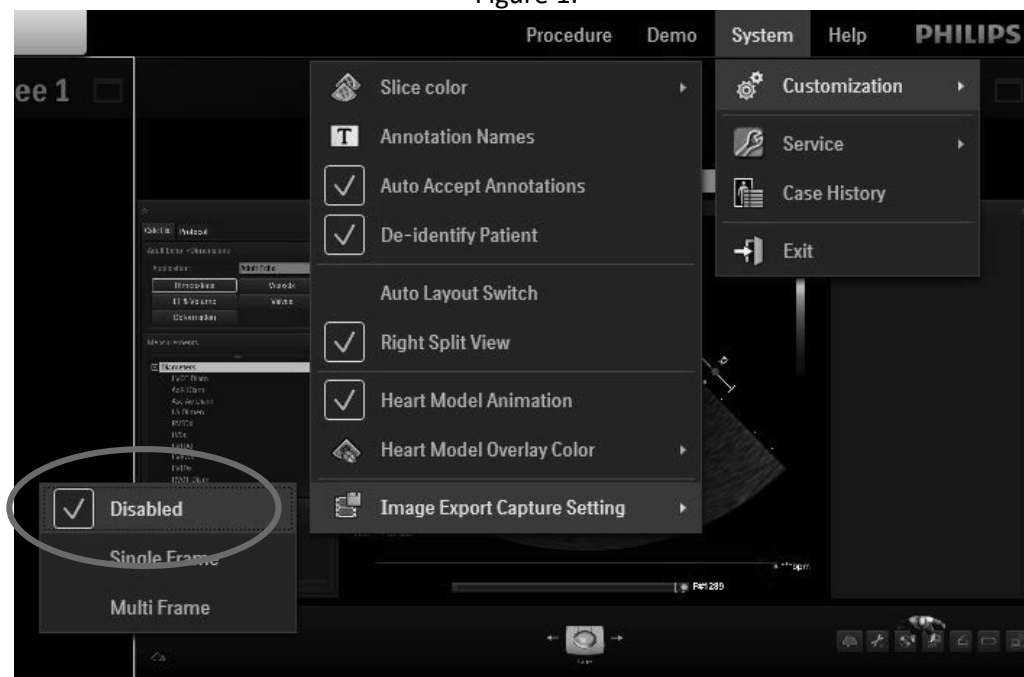
Figure 1.

Philips has become aware of a software issue that can potentially cause the EPIQ CVxi system to issue an error notification and become unresponsive during clinical use.

This issue can occur during ultrasound-guided Transesophageal Echocardiogram (TEE) procedures with EPIQ CVxi EchoNavigator, but only if secondary screen capture is enabled (recording real-time fusion of echocardiography and X-ray) and the user presses other buttons on the EPIQ system before the secondary capture has been completed.

- Philips recommends that you disable the secondary screen capture feature (i.e., *Image Export Capture Setting*) in the EchoNavigator system settings to prevent the system from becoming unresponsive due to this issue (as shown in Figure 1).
