**URGENT FIELD SAFETY NOTICE
MEDICAL DEVICE CORRECTION**

**FSCAs 2249723-06/02/2023-010-C, 2249723-06/02/2023-011-C,
2249723-06/02/2023-013-C & 2249723-06/02/2023-014-C**

Datascope Cardiosave Hybrid and Rescue Intra-Aortic Balloon Pumps (IABP)

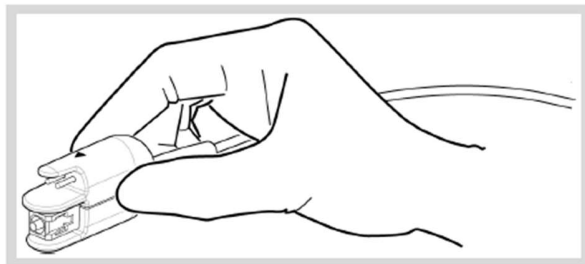
Figure 2-5: Grasping the Fiber-Optic sensor connector

The Fiber Optic connector is designed to fit smoothly into the IAB Sensor Input. The red triangle on the top of the connector should align with the red triangle on the Cardiosave console. Inserting the Fiber Optic connector into the port without verifying the correct alignment can lead to internal damage. If difficulty is encountered when inserting the connector, verify that the connector is in the correct position and attempt to reinsert into the IAB Sensor Input.

Excessive force can cause damage to the connector and the internal fiber optic assembly of the IABP console. This may cause a disruption in the fiber optic signal acquisition resulting in an inability to acquire a fiber optic signal on the Cardiosave IABP. Following proper insertion procedures will minimize the potential for damage to the connector and a loss of signal. This conclusion is based on field observations seen through the complaints evaluation. As part of Datascope's investigation testing will be performed to confirm this observation.

1. With one hand, grasp the Fiber-Optic Sensor Connector as shown in Grasping the Fiber-Optic sensor connector, with the red triangle visible on top.

Ensure that the red triangles on the Fiber-Optic IAB Sensor Connector and on the back panel are in alignment.

In step 4, when the Fiber-Optic connector is inserted into the IAB Sensor input until an audible "click" is confirmed, ensure that you are not using excessive force as that can lead to damage to the Cardiosave.
