URGENT FIELD SAFETY NOTICE MEDICAL DEVICE CORRECTION

FSCA 2249723-06/02/2023-009-C & FSCA 2249723-06/02/2023-012-C

Datascope Cardiosave Hybrid and Rescue Intra-Aortic Balloon Pumps (IABP)

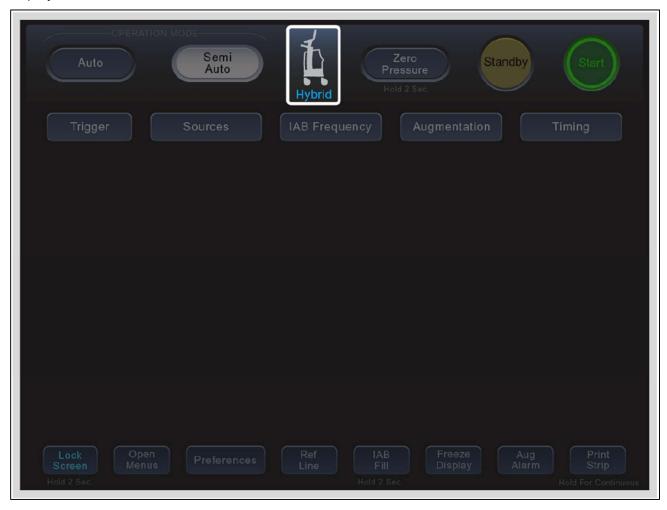
The IABP Configuration Icon shows the current mode of configuration for the IABP, Hybrid (in the hospital cart) Mode or Rescue (transport) Mode. The icon is located at the top center of the IABP display screen.

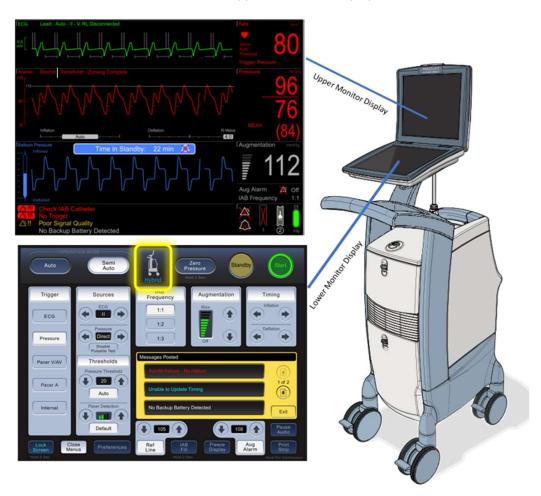
Cardiosave Upper and Lower Display

In both cases, information is provided to the user that the system is not in Hybrid mode via the Rescue Mode Icon on the bottom Cardiosave screen (top center of the screen). In addition, the "battery in use" message will be displayed in the informational message area even if the AC power cord is plugged in.

Additionally, in both scenarios, the Cardiosave will not receive AC power and if the device is in operation, it will continue to operate on battery. When the Cardiosave is not receiving AC power, the batteries are unable to charge.

If the AC Plug Icon is not present and/or the Rescue Icon is present, release the latch on the Hospital Cart located below the Pump Console, then grab the handle and slowly slide out the console approximately one quarter of the way.

Grab the handle and slowly slide the Pump Console into the Hospital Cart until it locks into place. You will hear an audible click noise and three audio tones of increasing volume will sound once the console is locked into the Hospital Cart.

To ensure the Pump Console was successfully installed into the Hospital Cart, plug the Hospital Cart power cord into a compatible grounded AC receptacle, and confirm AC operation by checking the battery icon to confirm the pump is using AC power.

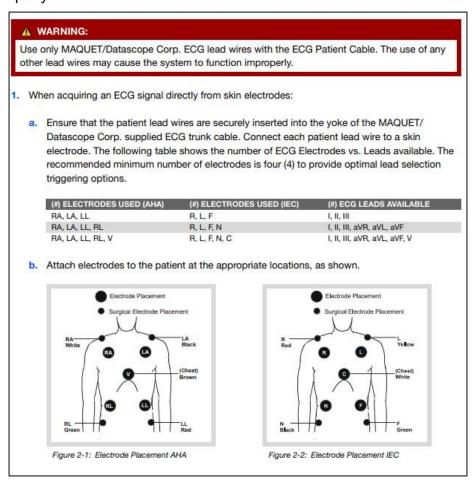
- Poor Quality Skin-Electrode Interface
- Front End PCBA Failure including Wetting (causes system to be unable to detect ECG lead faults)
- Faulty ECG Lead
- Failure of Executive Processor Board (the system cannot obtain or interpret the ECG)
- Defective ECG Lead Wire
- Defective Trunk Cable
- Defective connector between ECG cable and IABP unit

The type of skin electrode and application technique are major factors in determining the quality of the signal obtained. Use of MAQUET/Datascope electrodes is recommended. These are designed to acquire an ECG signal with excellent baseline stability, recovery from defibrillation and minimum artifact from patient movement. The use of Wet-Gel electrodes is recommended because, in general, they provide a better quality electrical contact immediately after being placed on the skin.

To ensure the safe and effective use of the Cardiosave IABP, follow the recommendation in the IFU, including the warning and Figures 2-1 and 2-2 regarding ECG lead placement locations and the use of third-party lead wires.
