**URGENT FIELD SAFETY NOTICE
MEDICAL DEVICE CORRECTION
FSCA 2249723-05/05/2023-008-C**

Datascope Cardiosave Hybrid and Rescue Intra-Aortic Balloon Pumps (IABP)

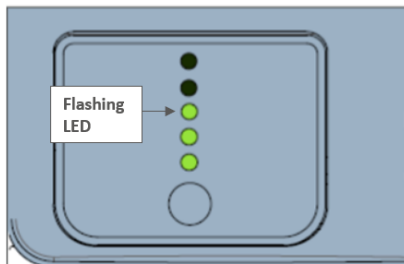
Figure 4: Battery 40%-60% Charging

Safe to remove battery

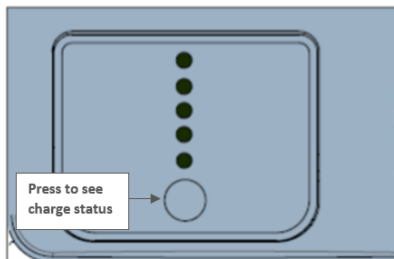
Figure 7: Not Actively Charging

Press button to view charge status
