# Urgent Field Safety Notice

## SBN-CPS-2019-017

## AssayTips with abnormal internal structure used on cobas e 801

<b>Product Name</b>	<b>AssayTip/AssayCup tray</b>
<b>GMMI / Part No</b>	05694302001
<b>Instrument/System Affected</b>	<b>cobas e 801 module</b> <b>cobas e 801 analytical unit</b>
<b>SW Version</b>	Not applicable
<b>Type of Action</b>	Field Safety Corrective Action (FSCA)

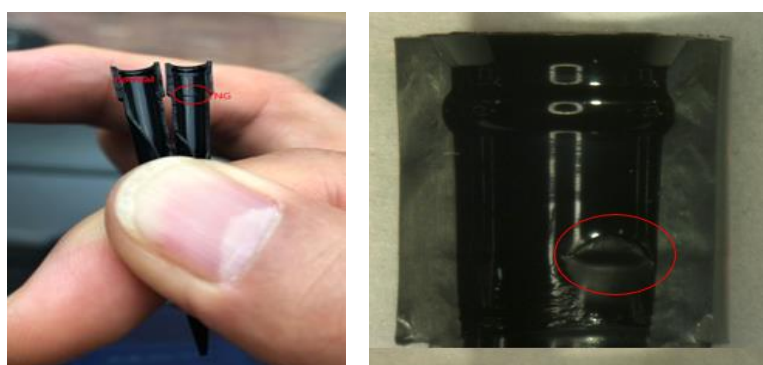
- Due to the abnormal internal structure, there might be a not optimal fit of the AssayTip with the sample probe. Thus, insufficient sample volume could be pipetted.
- Discrepant results without alarm message and/or flag cannot be excluded. Typically, low results of several consecutive measurements may occur.
- AssayTips with abnormal internal structure are likely to be found in groups in the tray (i.e. typically not a single isolated AssayTip with abnormal internal structure. Not all AssayTips from the affected lots are out of specification).

**Figure 3:** Examples of cut AssayTips with abnormal internal structure. The AssayTip includes a burr marked by a red circle.

An error affecting certain cavities of the production molds occurred in part of the production lines at our external supplier. This error led to the production of AssayTips with abnormal internal structure. The supplier has taken immediate corrective action in order to avoid re-occurrence of this issue. Current production is not affected by this error.

- Customers must check if they received affected AssayTips/AssayCup tray lots. Please compare your lots to the list of lot numbers provided (attached to this FSN).
- Customer must stop using the affected AssayTip/AssayCup tray lots and must discard the affected products locally.
- Customers are advised to also check the lot numbers of the trays placed on the instruments.
- In case that discrepant results are suspected during use of the affected lots, appropriate patient re-testing may be advisable, taking into account the patients' medical history and clinical examinations.
