URGENT – FIELD SAFETY NOTICE

Nimbus 4 & Nimbus Professional mattress – risk of over-inflation

Date:	2021-Apr-13
Product Issue:	Mattress over-inflation
Affected Product:	Arjo Nimbus 4 & Nimbus Professional mattress
Affected Serial No.:	Attachment A
Resolution:	Deactivate mattress grommet membrane
Field Safety Notice:	FSN-SUZ-001-2021
Pages:	2 & Customer Response Form
Single registration number of the manufacturer:	SE-MF-000000696

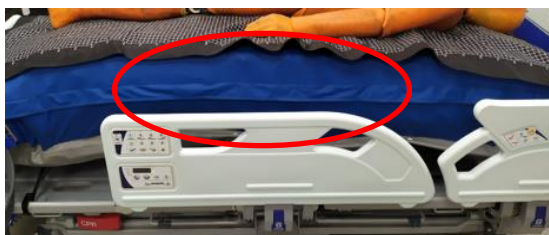
Arjo has received limited reports of the Nimbus 4/Professional mattress over-inflating which requires an unusual set of circumstances to occur. This is a very rare occurrence and there have been no reports of health consequences to either patients or caregivers due to this issue.

Our investigation has concluded that there is a remote possibility that a patient could fall from the mattress if the issue was to occur and was not detected by care givers. The issue is caused by inner mattress components that may fail after a certain period of time, however this is extremely rare and unfortunately cannot be detected until the product is disassembled.

Malfunctioning mattress

1. Transfer the patient to another appropriate surface
2. Turn off and unplug the pump.
3. Perform grommet membrane deactivation as instructed in the video to allow the accumulated air to freely vent out. Use a screw driver with a diameter of 2 – 3 mm. Make sure that the membrane is punctured through.

NOTE: The grommet membrane restricts the volume of excess air escaping. Removing the membrane will not affect mattress functionality in any way other than to allow excess air to escape at a slightly higher rate. This process does not introduce any new risks.
