URGENT - Medical Device Recall

Philips IntelliVue TRx4841A and TRx4851A Telemetry Transceivers

Potential Loss of Arrhythmia Monitoring When Using Telemetry Transceivers with Philips Patient Information Center iX Release C

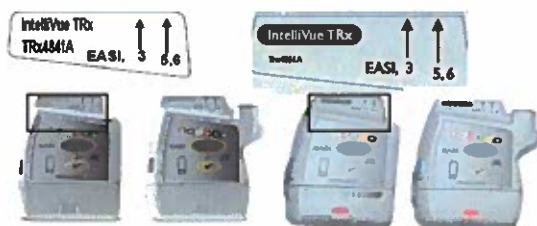
A Philips IntelliVue TRx4841A or TRx4851A Telemetry Transceiver can be identified by the label on the front of the device:

- Confirm whether PIC iX Release C.02.xx and C.03.01 is used anywhere in your facility, and if so:
 - Identify Philips TRx4841A and TRx4851A Telemetry Transceivers in your facility by using the instructions provide in the HOW TO IDENTIFY AFFECTED PRODUCTS section above.
 - Immediately discontinue use of the Philips TRx4841A and TRx4851A Telemetry Transceiver. Philips support for these devices ended in 2017.
- Complete, sign and return the reply form provided on the last page of this letter, as directed on the form.

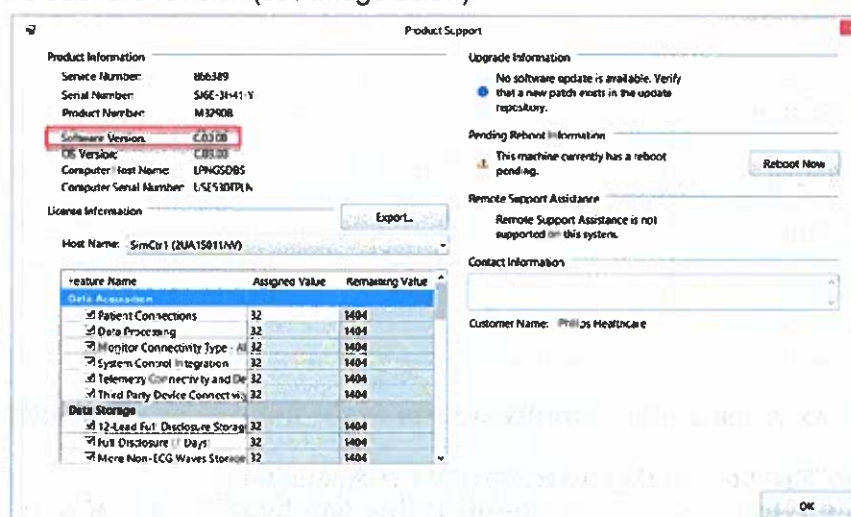
To identify the revision of software on the Philips Patient Information Center iX surveillance: Access the Product Support screen from the Main Setup task bar button or by clicking the Philips icon. This will bring up the Product Support screen which identifies the software revision (see image below).

Philips TRx4841A and TRx4851A Telemetry Transceivers, when used with Patient Information Center iX C.02.xx or C.03.01, are at risk of potentially exhibiting this behaviour. Philips has confirmed that this issue is not present when Philips TRx4841A and TRx4851A Telemetry Transceivers are used with PIIC Classic N.01.22, PIIC iX A.02.16, or PIIC iX B.02.18.
