Customer Safety Advisory Notice MR072/23/S

SAFETY ADVISORY NOTICE

Customer Information about possible artifacts from over-ear headphones during head examinations

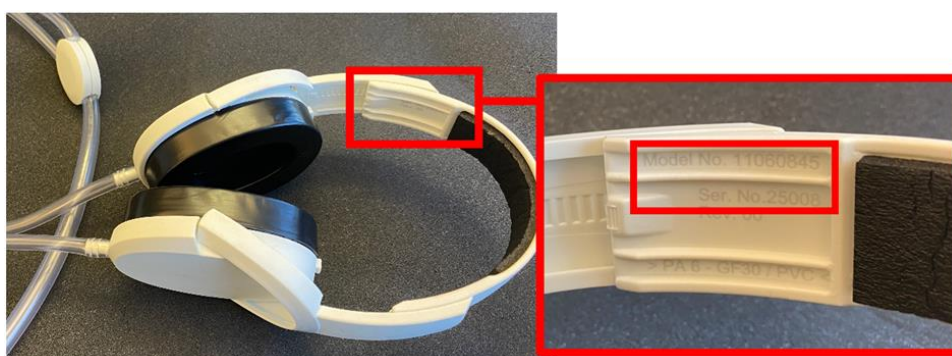
Name of the product	Siemens Model Number	Affected Headphones Serial Numbers
Over-ear headphones	11060845	7981 to 32200

Figure 1: Location of model number and serial number on over-ear headphones

- Check the model number and serial number of your over-ear headphones. See *Figure 1* for their location on the over-ear headphones. If the model number is not identical or the serial number is outside the stated range (7981 – 32200), they are not affected.

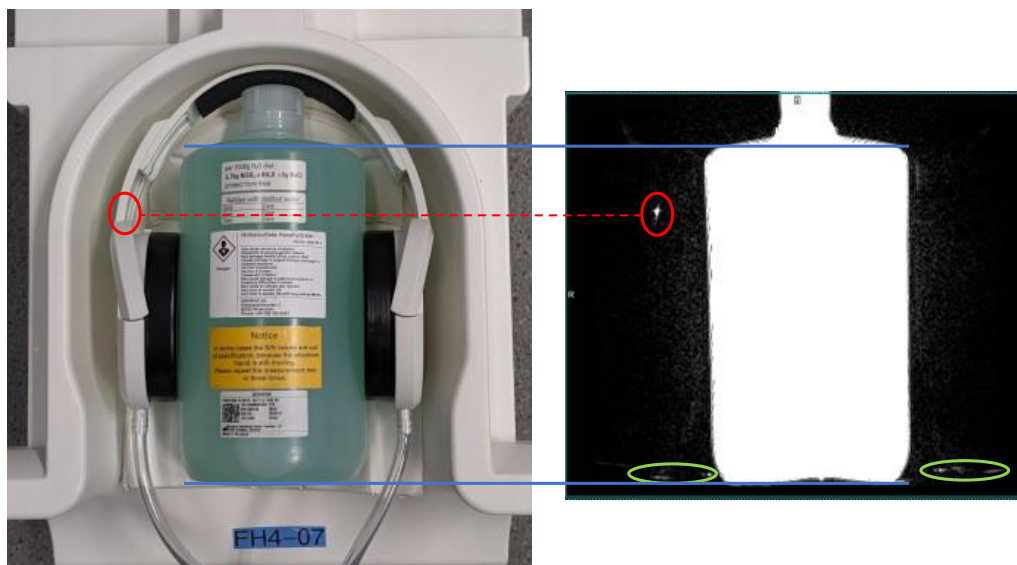
Figure 2

In some cases, when lubricating grease is present within the headband of the over-ear headphones, it may cause visible, dot- or line-shaped, fat-isointense artifacts during **head examinations only**. These potential artifacts depend on the position of the headband, the amount of lubricating grease, as well as the sequence parameters used. This issue does not impact scans of other body regions.

In rare cases, when clumps of lubricating grease are present within the headband in combination with the use of T1-weighted sequences and high acquisition acceleration (e.g., PAT acceleration factor of 2 or more) the artifacts may fold in and be visible as dot or line shaped hyperintensities inside the skull anatomy. The following sequences are prone to the described behavior:

Left side: correct setup of phantom bottle and headphones in head coil

Right side: Example of signal from lubricating grease can be seen outside the phantom, marked with a red circle. The artifacts must be on the same height as the potential affected headbands of the headphone.

Please note: MR imaging often shows artifacts with phantom bottles in this extreme windowing e.g., at the top and/or bottom of the phantom. These artifacts are marked with green circles in the above example and can be ignored.

- ➔ **If no artifacts are visible** during the described phantom measurements, your over-ear headphones are not affected and can continue to be used for MRI head examinations.

- ➔ **If artifacts are visible** during the described phantom measurements, your over-ear headphones are affected and must not be used for head examinations. In this case, please use the built-in loudspeaker in the scanner for patient communication or, if available, in-ear headphones which are also not affected by the described issue.

Siemens Healthineers will correct the issue by exchanging the headband of the affected over-ear headphones at customer sites with the field update MR073/23/S. This replacement program will start in October 2023. With the exchange of the headband the root cause is eliminated.
