Urgent Field Safety Notice
Product Correction
Immediate Action Required

Date Issued December 8, 2017

Product Name	List Number	UDI
ARCHITECT c4000 Cuvette Segment	02P75-01	Not applicable
ARCHITECT c8000 Cuvette Segment	01G46-01	Not applicable
ARCHITECT c16000 Cuvette Segment	09D32-05	Not applicable

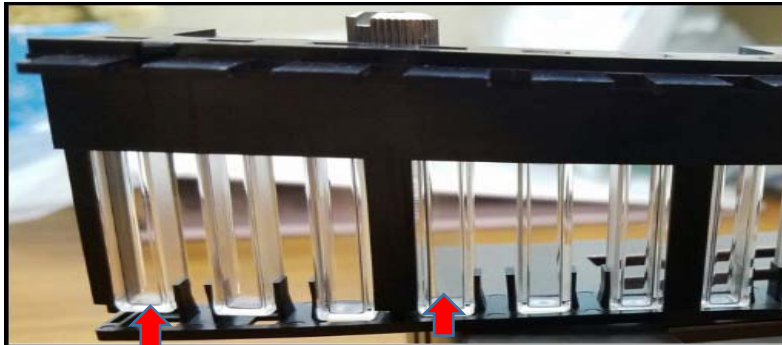
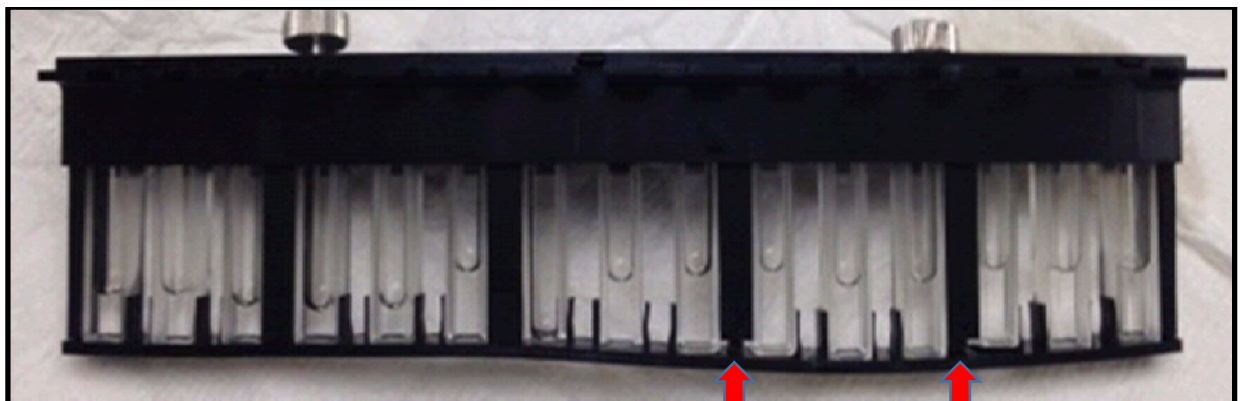
The base of the ARCHITECT Cuvette Segment may become detached under specific conditions. When a cuvette segment base is detached, cuvettes may be seated lower than the designed height. This may result in inadequate dispense into specific cuvettes due to the sample probe being unable to make efficient contact with the cuvette bottom.

The following pictures show examples of cuvette segments where the base is detached from the vertical support post.

The red arrows indicate where the base has become detached from the vertical support posts

If a cuvette segment with a detached bottom is identified, replace it before performing any additional testing on your ARCHITECT Clinical Chemistry System.
