Urgent Field Safety Notice

Software Distribution Network & Associated Programmers

Product Name	Model Number
CareLink™ 2090 Programmer	2090; All Serial Numbers
CareLink Encore™ 29901 Programmer	29901; All Serial Numbers

October 2018

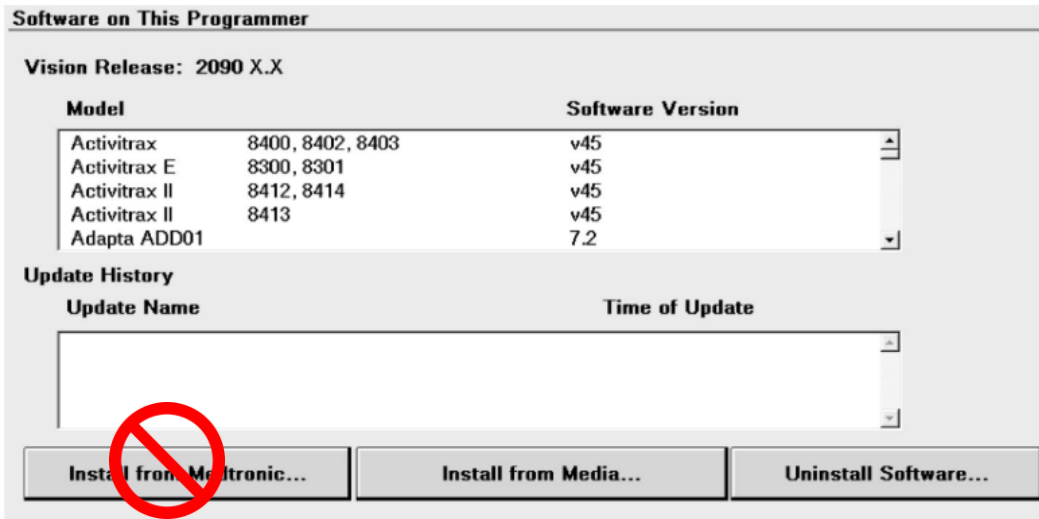
Appendix A Programmer Software Screen

Do not attempt to update the programmer via the SDN. If you select the "Install from Medtronic" button, it will result in an unsuccessful installation of software because access to the external SDN is no longer available.

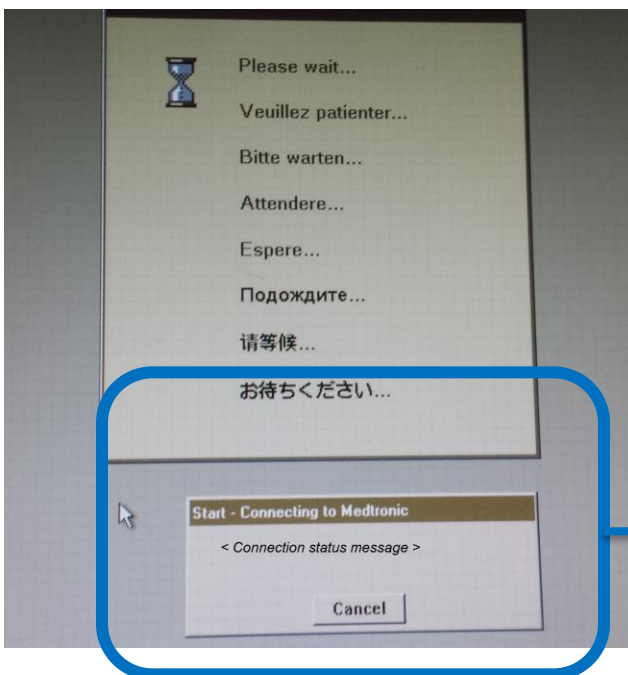
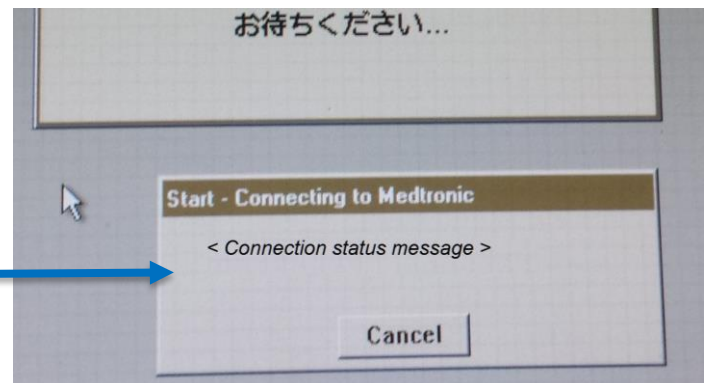
Several messages may be observed if installation of software from the SDN is attempted (e.g. "Install from Medtronic..."). See images below for example as to what will appear on the programmer display during the installation attempt. Below the larger "Please Wait" message will be a smaller window with a <connection status message> displayed; refer to highlighted area below. The connection status messages may alternate *between* "Connecting...", "Searching for Network...", "Logging in...", "Unable to connect to local network", and "Unable to connect to Medtronic". Since the SDN is no longer available, **the user should select "Cancel" to terminate the installation attempt.**

If the user cycles power on the programmer without first cancelling the installation attempt, upon power-up a count-down window will appear on the screen for approximately 30 seconds with "Yes" and "No" buttons. The user should select "No" to terminate the installation attempt and return to the Model Select screen. If the user selects "Yes" or does not respond prior to the 30-second time out, the programmer will attempt the installation again, and the process described above will repeat until the user either selects "Cancel" or selects "No" during the count-down window.
