Urgent Field Safety Notice

29901 CareLink Encore™ Programmer Power Supply Model 26907 Recall

January 2019

Medtronic Reference: FA860

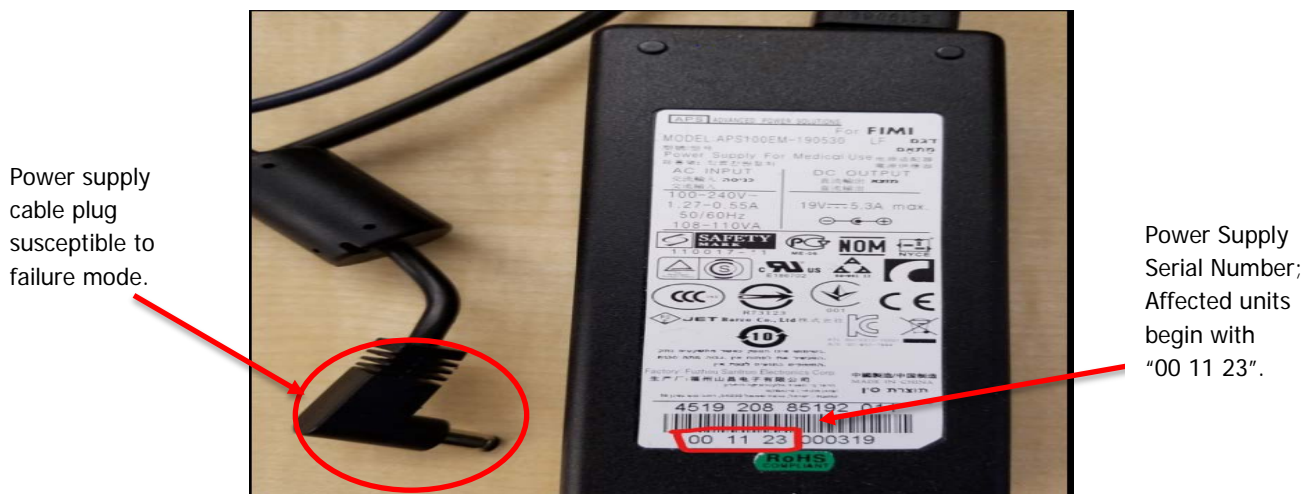
FIGURE 1

The affected power supplies were potentially packaged with a subset of Model 29901 CareLink Encore Programmers distributed in the US, India and specific countries in Europe, and the Middle East. Each affected power supply has a serial number beginning with "00 11 23 xxxxxx" (refer to Figure 1). The potential for an electrical short circuit to develop in the cable plug is specific to this subset of power supplies. Encore programmer power supply units outside of the identified Serial Number list are not in scope of this advisory and do not need to be replaced. Model 26907 power supplies are not compatible with other Medtronic programmers (e.g. CareLink Programmer Model 2090).

- Discontinue use of any power supply immediately if you observe overheating, smoke or melting near and around the power supply cable plug to the programmer (refer to Figure 1). Notify your local Medtronic representative to report the observed failure.

Please work with your local Medtronic representative for identifying and replacing any affected power supply with a serial number that begins with "00 11 23".
