IMPORTANT FIELD SAFETY NOTICE

CentriMag™ Acute Circulatory Support System Motor Model: 201-10002
Compatible with CentriMag™ Pump and PediVas™ Pump

September 5, 2018

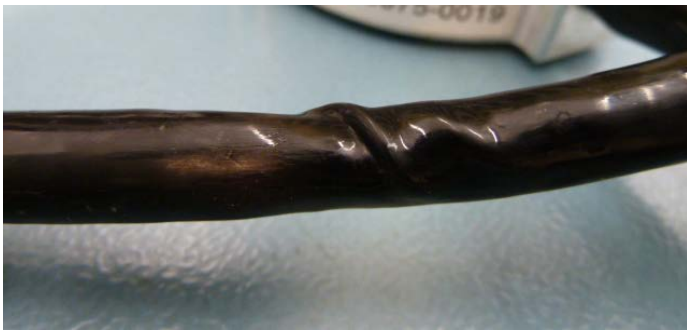
Figure 7: Damaged Motor Cable

Before each use, verify that the cable connecting the Motor to the Console is not kinked, which can occur with improper handling such as wrapping the cable tightly around the Motor. If the cable is kinked, replace the Motor.

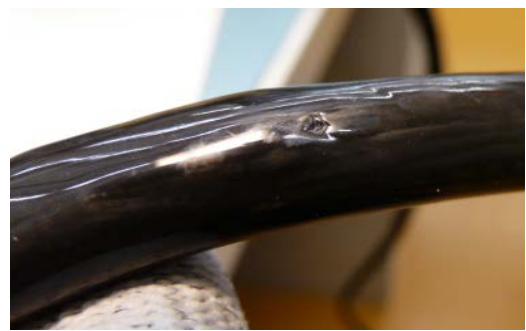
Figure 8: Damaged Motor Cable
