## Urgent: Field Safety Notice / FSCA 004-18

Product name	Reference number	Versions
IH-Com Fullversion	009000	5.1.7 and 5.1.10
IH-Com for Reader	009010

### Description of the problem:

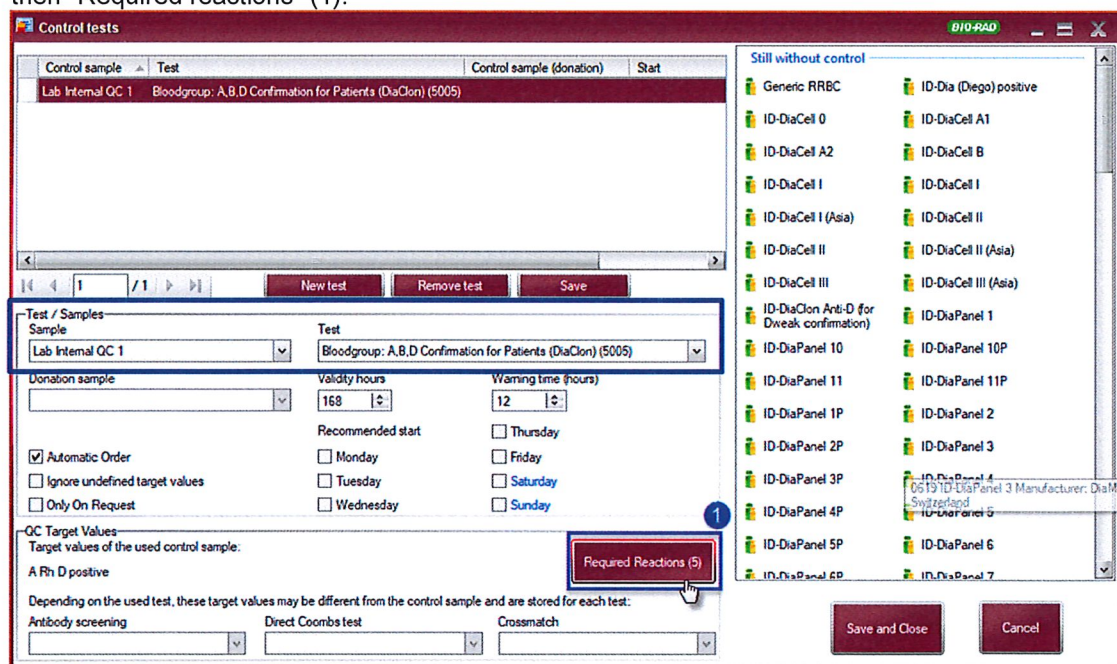
- I. A workaround exists and consists of manually defining the claimed reaction for the QC. It must be applied as follows:
  1. Navigate to the settings "Control tests" in the QC module of IH-Com, select the test and the sample, then "Required reactions" (1):

2. Select the well by clicking on "+" (2), then click on the drop down menu (3) and choose the field name of the selected well (4).

3. Click on the drop down menu (5) and select the claimed reaction for the selected field name (6) and close the window.

4. Repeat steps 1-3 to define reactions for all wells
