Subject: Pacemakers – Technical programming information on Minute Ventilation Sensor.
Ref.: 92186345-FA

Product name	Models
VALITUDE™ CRT-P	U125, U128
ACCOLADE™ Pacemakers	L300, L301, L310, L311, L321, L331
ESSENTIO™ Pacemakers	L100, L101, L110, L111, L121, L131
VISIONIST™ CRT-P	U225, U226, U228
PROONENT™ Pacemakers	L200, L201, L209, L210, L211, L221, L231
ALTRUA™ 2 Pacemakers	S701, S702, S722

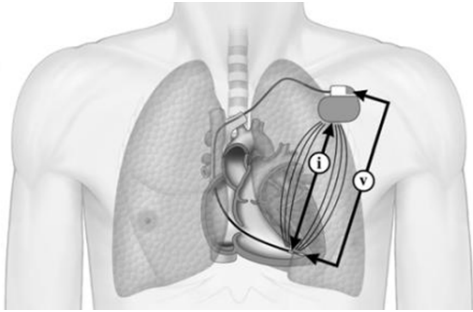
Figure 1. Measurement of the MV Signal from the RV lead

Boston Scientific pacemakers use transthoracic impedance to measure MV which is a product of respiration rate and tidal volume. During inhalation, the increased volume of air in the chest cavity produces an increase in transthoracic impedance. Likewise, during exhalation, the decreased volume of air produces a decrease in transthoracic impedance. Transthoracic impedance measurements are obtained through delivering a subthreshold current waveform approximately every 50 ms between the lead ring electrode and the pacemaker case, and measuring the resultant voltage between the lead tip and the pacemaker case (Figure 1). Boston Scientific pacemakers use the MV sensor for RightRate™ (rate adaptive pacing), Respiratory Rate Trend, and AP Scan™⁶.

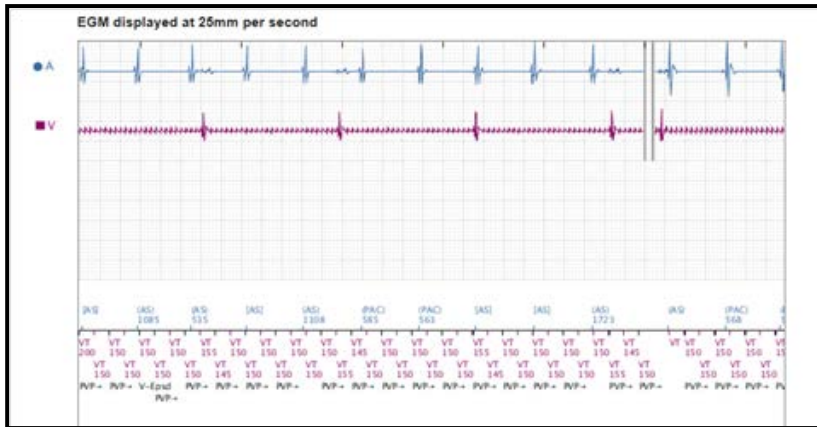
Figure 2. Example of MV signal oversensing

Engineering analysis and testing, as well as evaluation of post-market surveillance data, demonstrates an elevated potential for oversensing of the MV sensor signal in certain pacemaker systems connected to Medtronic or Abbott pacing leads. Although all leads evaluated in simulated testing environments comply with appropriate connector standards³, we have discovered subtle differences amongst lead manufacturers in the surface finish of the lead terminal ring and amount of axial and radial terminal ring motion within the pacemaker header. These factors may result in intermittent increases in impedance leading to oversensing of the MV sensor signal or changes in daily impedance test measurements.

²Such as lead conductor fracture, under-insertion of the lead terminal, or axial/radial motion of the lead terminal's ring electrode within the pacemaker header

Boston Scientific pacemakers perform an MV lead check approximately every hour to assess lead and lead connection integrity. The active vector may be the primary vector (distal RA ring electrode to the pacemaker case) or secondary vector (distal RV ring electrode to the pacemaker case). Since either vector may be used to measure MV, at least one of the implanted leads must have normal bipolar lead impedances. Typically the MV sensor signal is appropriately filtered out by the pacemaker. However, if a high impedance condition is detected within the lead-pacemaker system, the MV sensor signal may be oversensed (Figure 2).

- For pacemaker-dependent patients, turn the MV sensor “OFF”. Note when programmed to passive, the MV sensor signal is enabled and may be oversensed. See Appendix B for details on turning the MV sensor “OFF”.

- In accordance with the pacemaker manual, if MV sensor signal artifacts are observed on EGMs and leads are performing appropriately, consider programming the sensor to “OFF” to prevent oversensing.
