Urgent Field Safety Notice

Prismaflex Control Unit

FA-2019-050

Device Correction

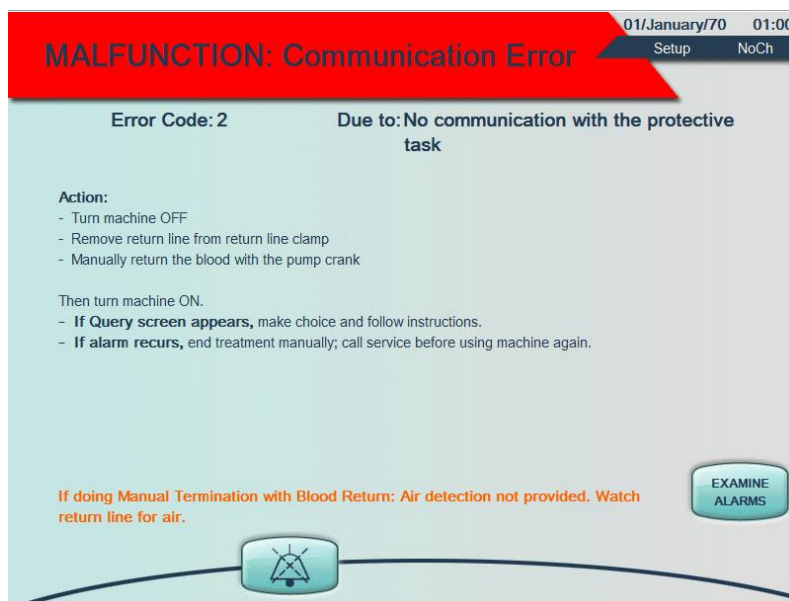
The following actions occur during a communication error alarm:

- The Prismaflex control unit enters a “safe state” by stopping all pumps and closing the return line clamp. Treatment is suspended. The patient’s blood does not circulate through the blood flow path.
- Red flashing light
- Recurring high-pitched sound of 10 sound pulses repeated approximately every 8 seconds until muted.
- Malfunction screen appears on the display as pictured below. The instructions to the user are the same for all error codes.

1. Operators may continue to safely use the Prismaflex control units until the upgrade is performed. If a communication error alarm does occur, follow the instructions presented on the graphical user interface and/or in the operator's manual. Please reinforce the importance to manually return the extracorporeal blood to the patient, and re-train users on this process, outlined on page 10:57 (to be adapted locally) of the operator's manual, if necessary.
