Humidity Packs Incorrectly Identified as Expired (Lot 0010)

Reason for Urgent Field Safety Notice

This response form is to confirm receipt of the enclosed Siemens Healthcare Diagnostics Urgent Field Safety Notice (UFSN) ASW20-02.A.OUS, dated January 2020 titled "Humidity Packs Incorrectly Identified as Expired (Lot 0010)". Please read each question and indicate the appropriate answer.

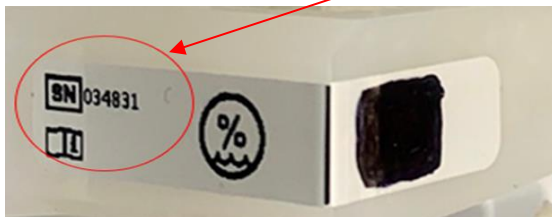
- c. The unique identifier on the Humidity Pack label is depicted below. In this example the unique identifier is 034831. (side view)

6. Enter the following barcode number.

- a. 78710600PPPPPP

- b. P P P P P P is a unique six-digit pack number. Use the unique identifier on the Humidity Pack being manually entered.

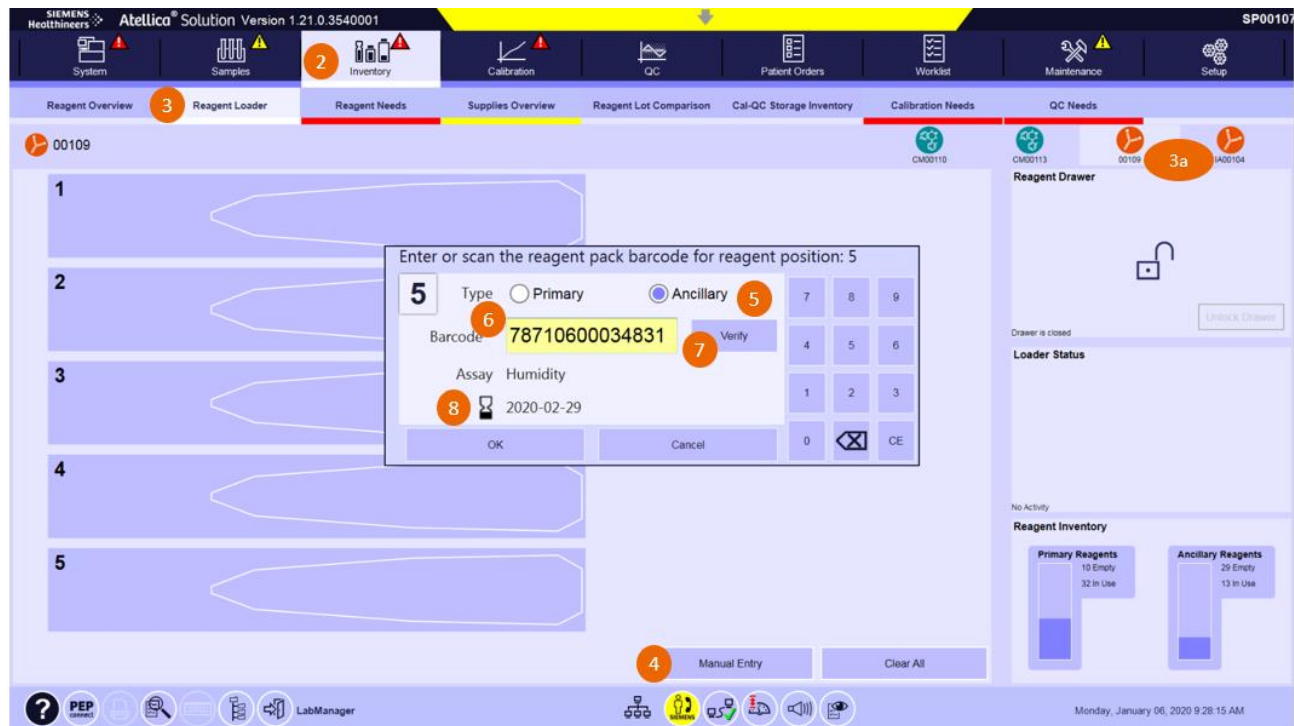
Note: Steps 2 through 8 correspond to the screen shot on page 3 below.

8. Confirm Assay equals Humidity and the date next to the hourglass symbol is 2020-02-29.
9. Select OK.
10. Load the Humidity Pack in position 5 of the reagent tray.
11. Repeat this procedure for all required Humidity Packs. Each analyzer will require, 7 to 10 packs based on analyzer environmental requirements. When the full set of required Humidity Packs are loaded, the analyzer will resume normal operation.
