<b>Hillrom™</b> Hillrom Luleå Nedre Vägen 100, 975 92 Luleå, Sweden	<b>Field Safety Notice</b>	<b>FA 2021-05-002-LUL-003</b>
---	----------------------------	-------------------------------

**Field Action Identifier: FA 2021-05-002-LUL-003**

OctoStretch with Stretch Leveller, FlexoStretch, Stretch Leveller, LikoStretch 1900, Liko Stretch Mod 600 IC.

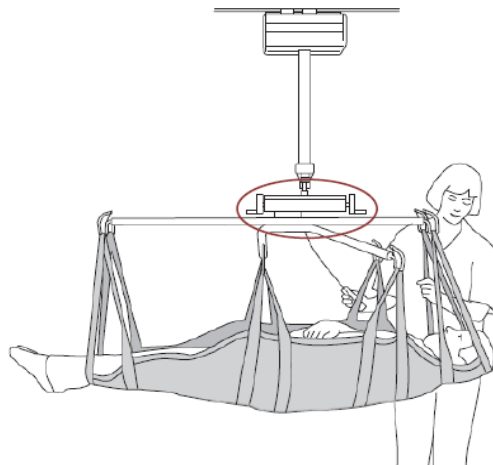
Fig 1:

Hillrom has become aware of a user report of Leveller breakage used with the Octo Stretch.

As a result of the breakage the Stretch Leveller has the potential to lose the function of maintaining a patient in the horizontal position when lifting and in motion. When this function is lost the patient can slide backwards and potentially may fall out of the Oct lift sheet back onto the surface it is being lifted from. See Figure 1: OctoStretch with Leveller in use, Stretch Leveller circled.

Hillrom is replacing the stretch leveller to mitigate this risk of breakage. Upon completion of the enhancement(s), Hillrom will contact customers to coordinate update of the leveller device.

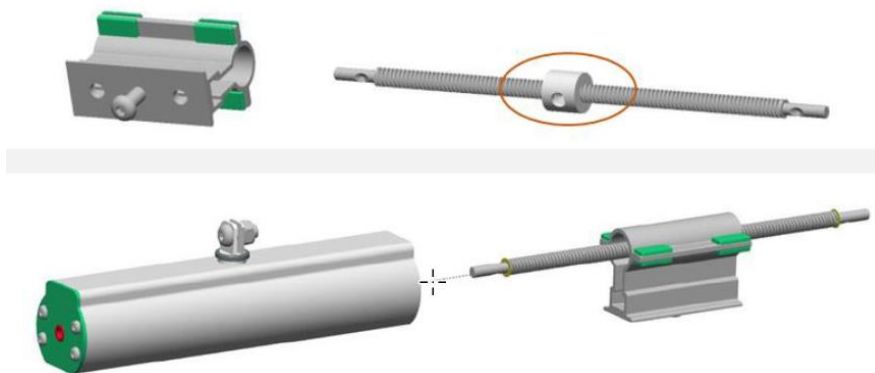
Fig 2:

The function of the Stretch Leveller connected to the OctoStretch is to allow for adjustment of the center of gravity during lift. The Stretch Leveller is composed of a trapezoidal nut attached to an attachment profile on a threaded rod. If the trapezoidal nut breaks the leveller can shift center of gravity without the user activating the function, causing the stretcher to tilt unexpectedly. See Figure 2: Main components and assembly of Stretch Leveller. Trapezoidal nut circled.
