Urgent Medical Device Field Action

MAR-18-2022 | REF-605552 | Rev A

Subject: VOLISTA paint chipping

Volista StandOp cupolas which has been manufactured until 31-Dec-2020.

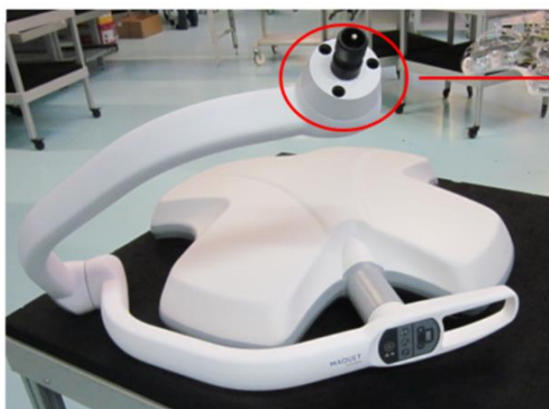
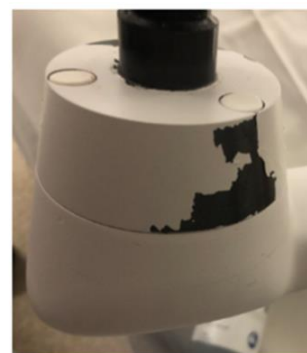
Under certain conditions, it was established that the paint could chip on a specific part of the fork. Therefore, there is a risk probability that paint particles may detached and fall in the operating field.

- The paint peeling is located on a specific part of the fork, as shown on the pictures below:

This issue may result at worst in a potential infection if particles fall during surgical operation in the patient body or in the operating field.

For remediating to this possible paint chipping, we require your contribution in paying attention to your device, and then if you experience the paint chipping on the affected part, to follow the instruction for our service support to replace the part with one with improved paint adhesion.

- Should you detect a paint peeling on this part of the fork, please evaluate if you should stop using your Volista and contact systematically your Getinge representative.

The Getinge Representative and our Service Support will proceed with the replacement in the shortest time-interval.

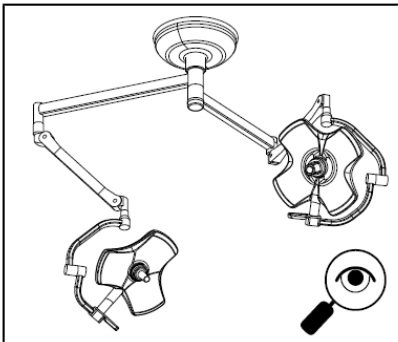
Fig. 27: Integrity of the device

Integrity of the device

1. Check that the device has not suffered any impact damage.
2. Check for any chipped or missing paint.
3. If a problem is noted, contact technical support.

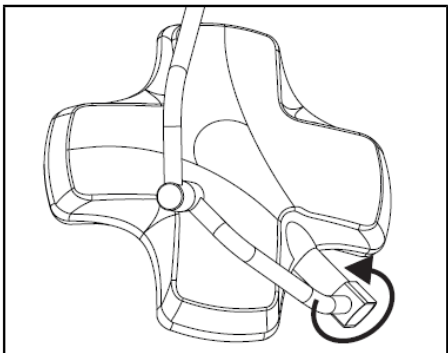
Fig. 39: Integrity of the lighthouse

Integrity of the lighthouse

1. Check the lighthouses for chipped paint, impact marks and any other damage.
2. Check that the lighthouse rotates correctly.
3. Check that the lighthouse does not drift.
4. If a problem is noted, contact technical support.
