Olympus reference: QIL FY26-EMEA-17-FY25-009-A Thunderbeat Probe Fracture and Tissue Pad Detachment

## URGENT FIELD SAFETY NOTICE

RE: THUNDERBEAT™ Hand Instrument

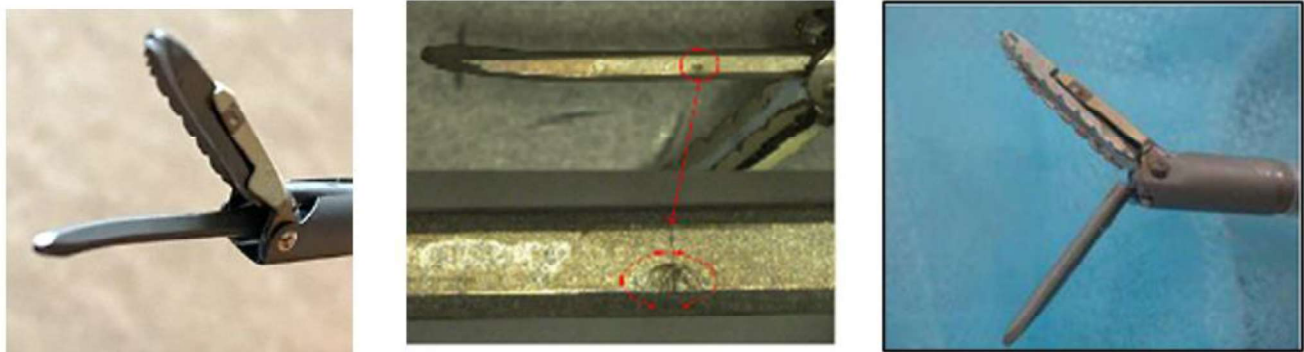
- **Probe tip damage or breakage** - Multiple instances where probe tips of THUNDERBEAT™ Type S hand instruments have become damaged or broken during use (reference example in Figure 1).
- **Tissue pad issues** - Reports of tissue pad damage or detachment from the instruments (reference example in Figure 2).

Olympus was made aware, via customer complaints, of reports where probe tips of THUNDERBEAT™ hand instruments are becoming damaged or are breaking (reference example in Figure 1), as well as instances of tissue pad damage or detachment (reference example in Figure 2). Investigations by Olympus demonstrated that these issues can occur when the instructions and warnings in the IFU are not followed, specifically, taking very large bites of tissue, contact with metal while activating, and activation without tissue between the jaws. However, due to a continuation of occurrences of this issue, Olympus is removing potentially affected models of THUNDERBEAT™ hand instruments from the market.

*Figure 1. Example of Thunderbeat Probe in accordance with specifications (left), Cracked Probe (Center) and Probe Fracture (right)*

1. Examine your inventory for affected Thunderbeat hand instrument models as listed on page 1 of this FSN.
2. **Immediately cease use of all affected devices and quarantine the products.**
3. If you have affected products in your inventory, please contact Olympus with regard to return of affected products. Olympus will issue a credit to your facility upon return of your affected product
4. Olympus requests that you acknowledge receipt of this FSN.
5. If you have further distributed THUNDERBEAT™ devices, please identify your customers and forward this notice to them immediately.

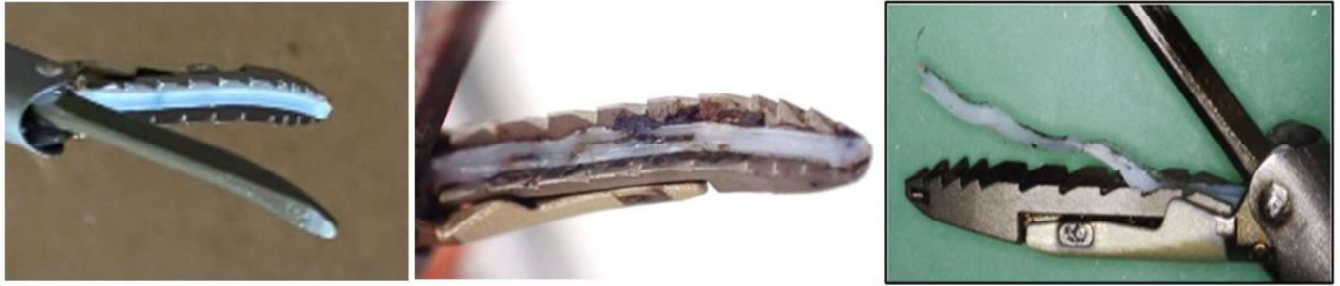
Figure 2. Example of Thunderbeat Probe in accordance with specifications (Left), Tissue Pad Deformation (Center), Tissue Pad Detachment (Right)
