URGENT FIELD SAFETY NOTICE

bellavista™ Ventilators

Ceasing of Ventilation with Technical Failure Alarm 305
for Field Safety Corrective Action FSCA-2021-001

FSN Ref: FSCA-2021-001-FSN-1

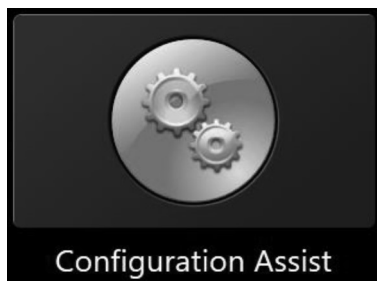
1. Open **Configuration Assist**.

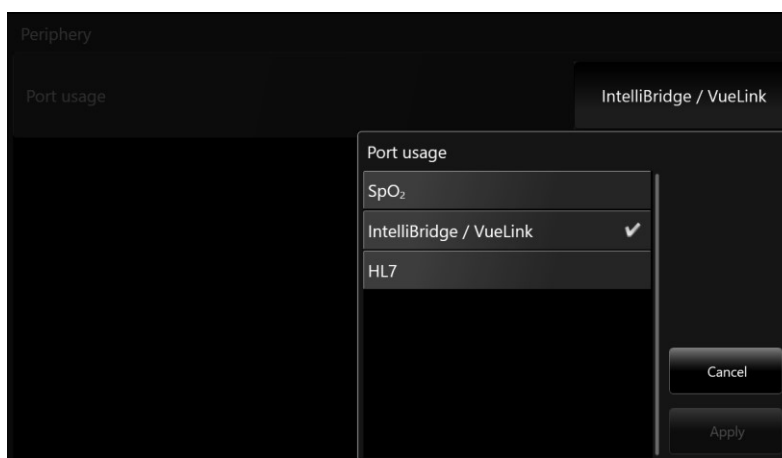
3. Ensure that **Port usage** is **NOT** configured to "HL7".

For 13.3" devices, select "IntelliBridge / VueLink" or "SpO₂".

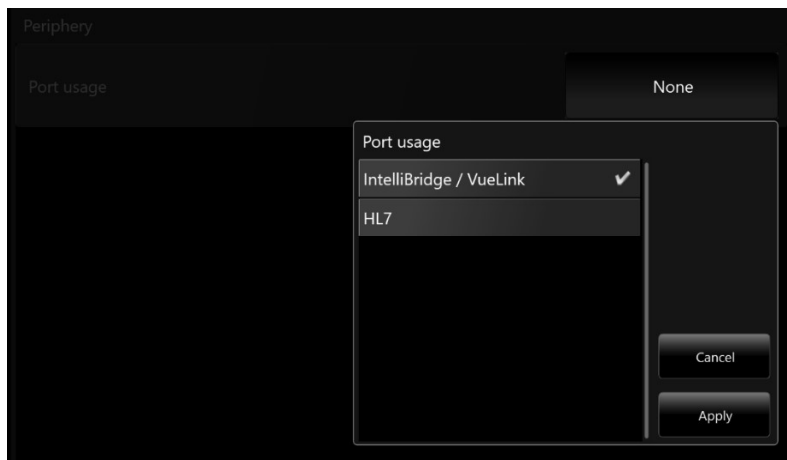
For 17.3" devices, select "IntelliBridge / VueLink".
