## **Urgent Field Safety Notice** **Column iC**

### **Service Note NIM04-2021**

*Subject:* Pin soldering verification

*Equipment:* Column iC

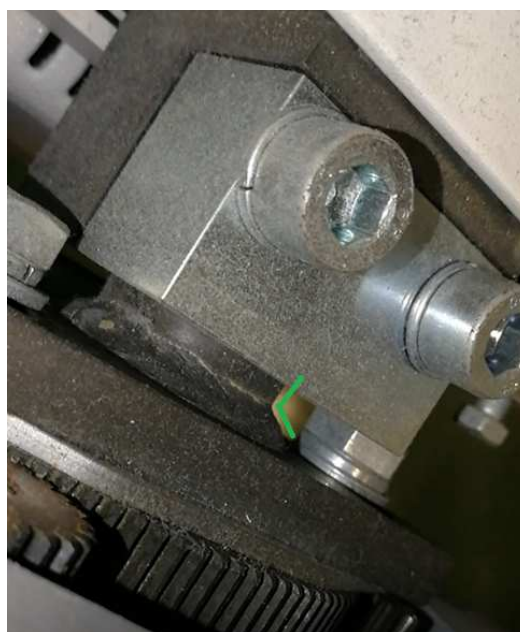
Just for reference, here following the type of verification to be done in field on installed units, where it is visible, without dismounting x-ray tube, the difference between correct welding, that should have the weld throat size of about 4mm, and non compliant welding

In green you can see the correct weld throat size

In case you find this type of welding, it is required the tube support replacement.

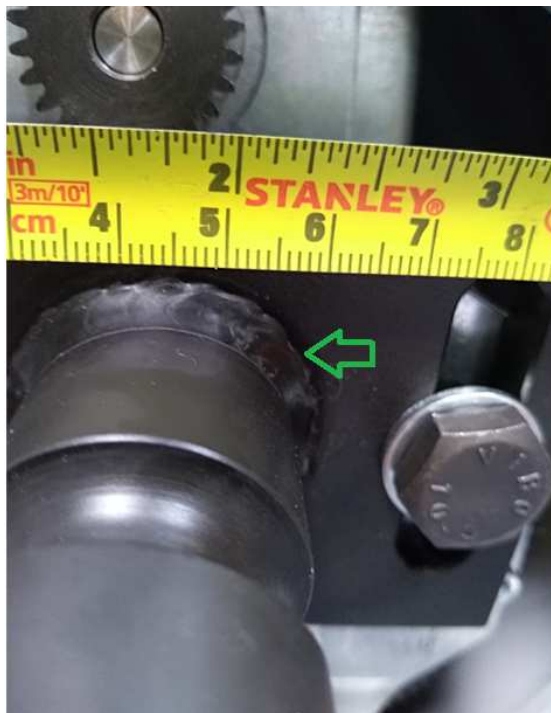
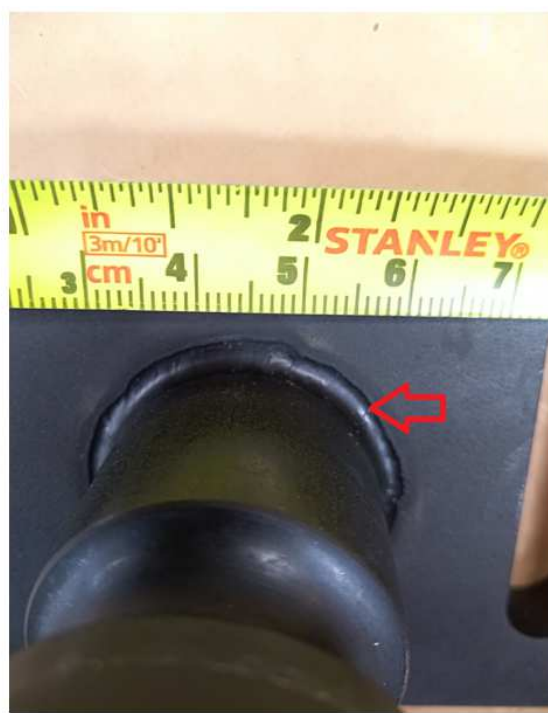
For better understanding, here following the differences between a correct welding (green arrow) and a non compliant welding (red arrow).

In case it is necessary the replacement, the spare part code is:

- code 5288701200 pin for Column iC:

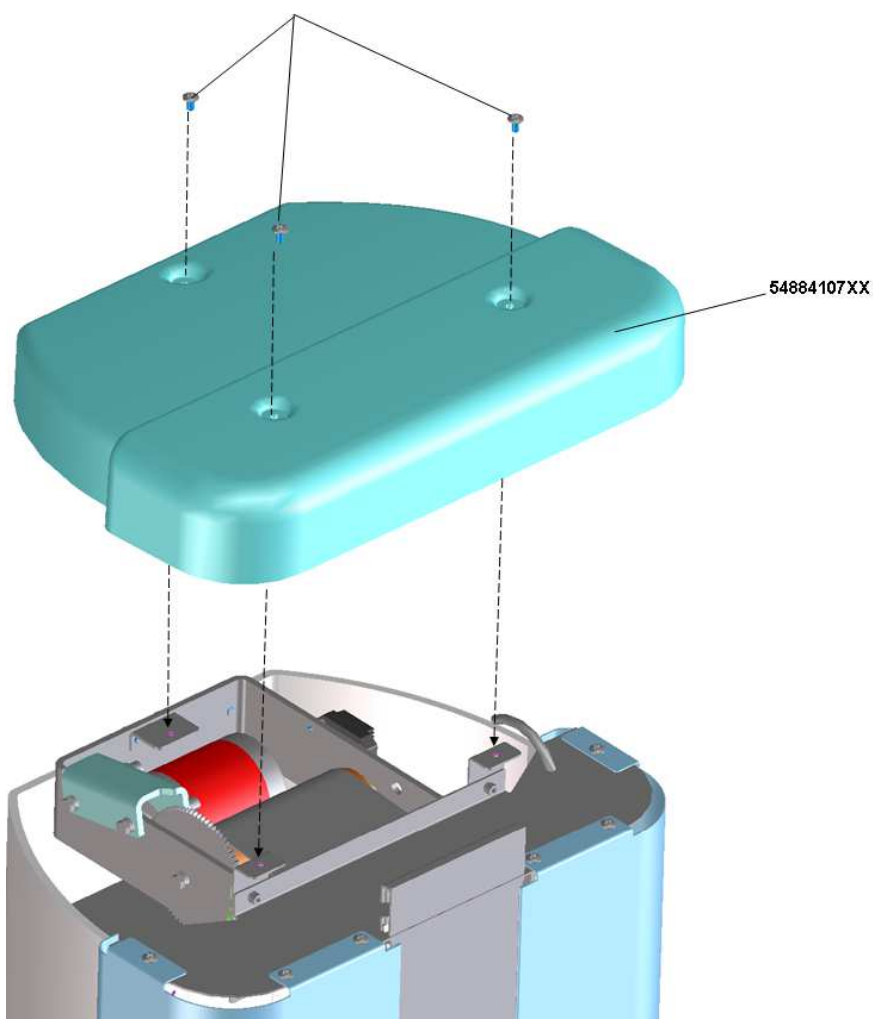
Remove plastic upper cover of the Column iC,

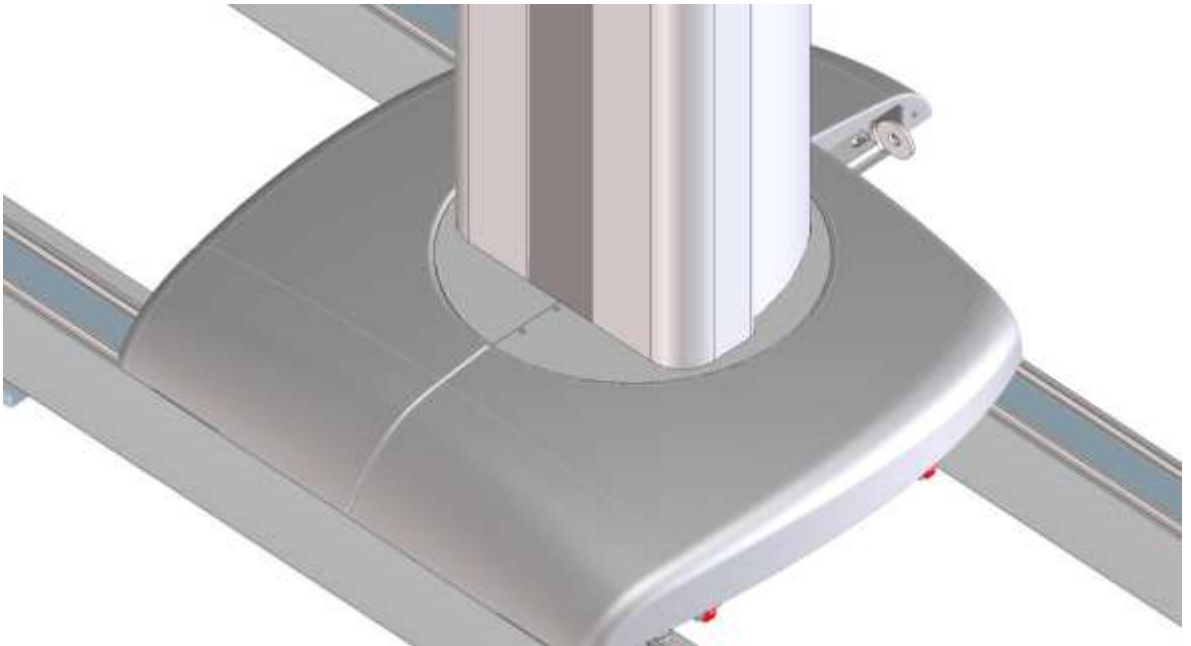
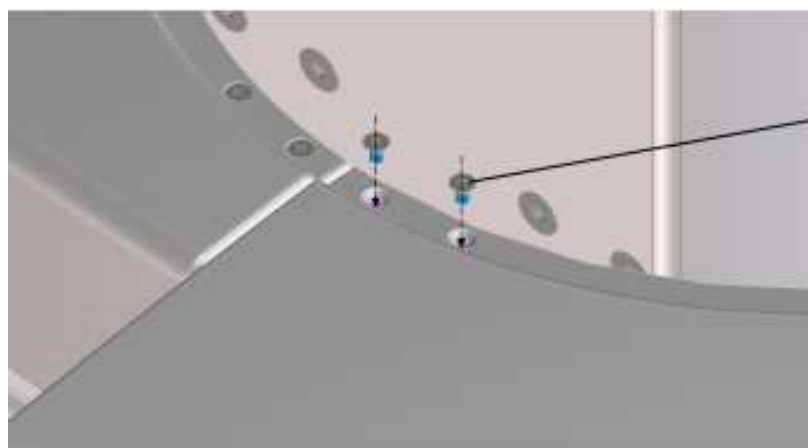
Remove the base covers

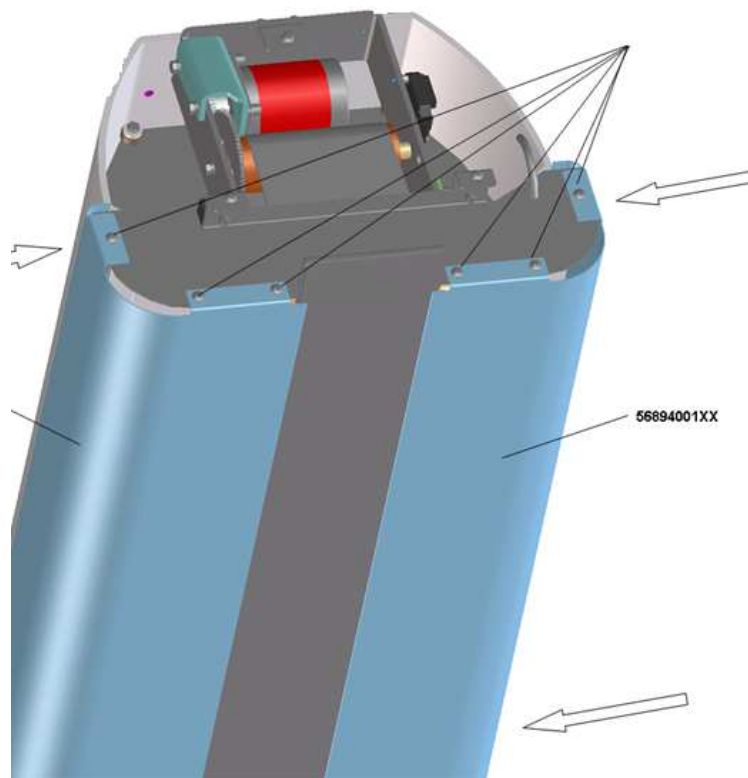
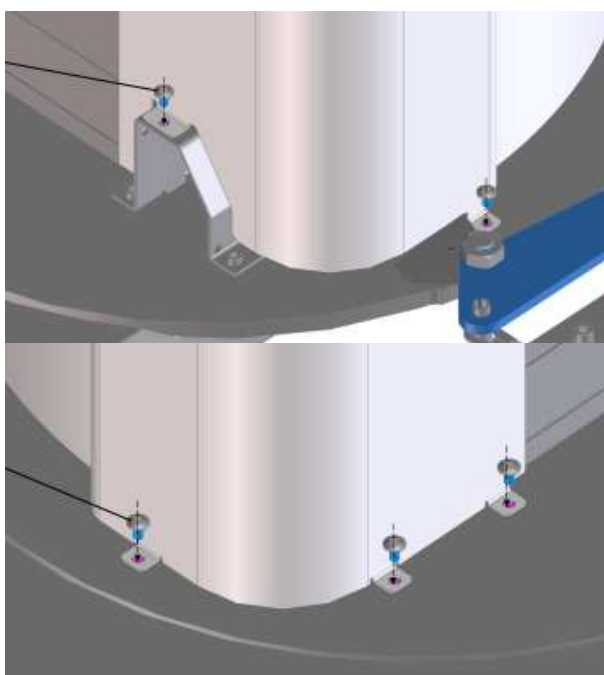
Remove lateral covers

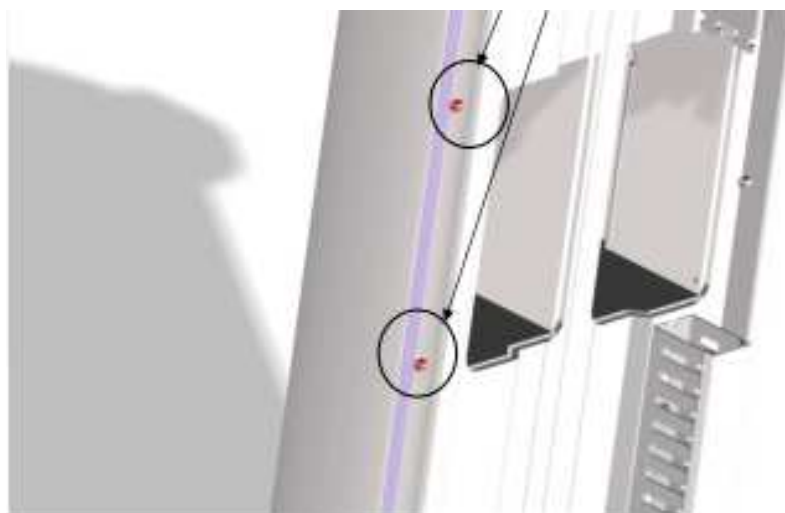
Move the upper part of the counterweight box, depending on the models, the fixing could be front with the two M6 screws in the appropriate holes or lateral with two M5 screws.

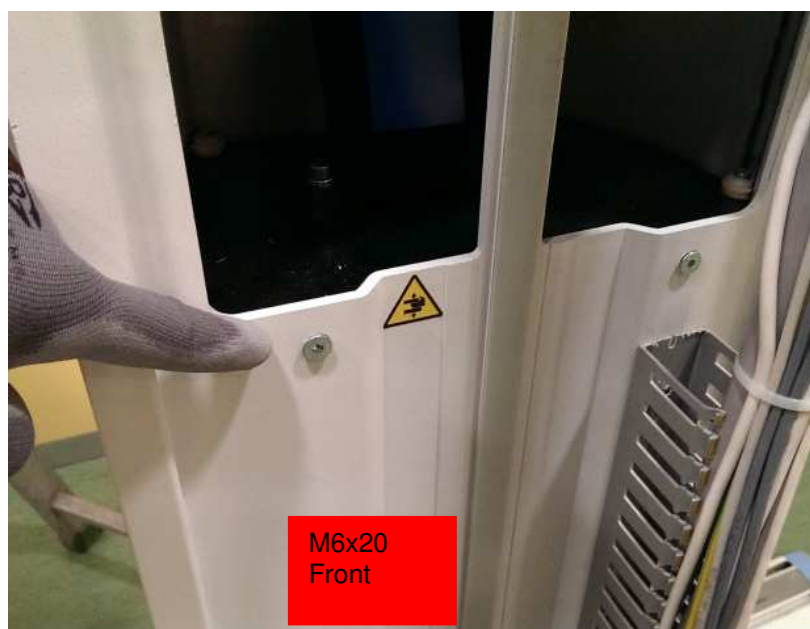
Old systems had fixing screws in front side

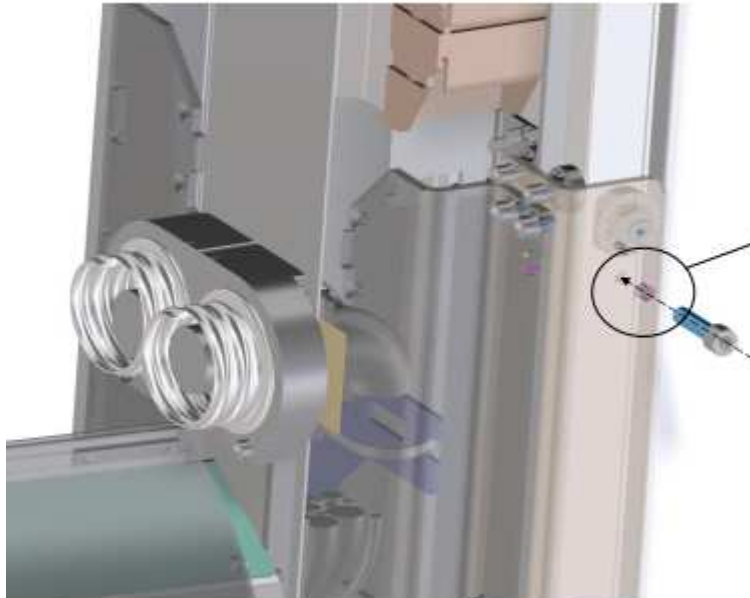
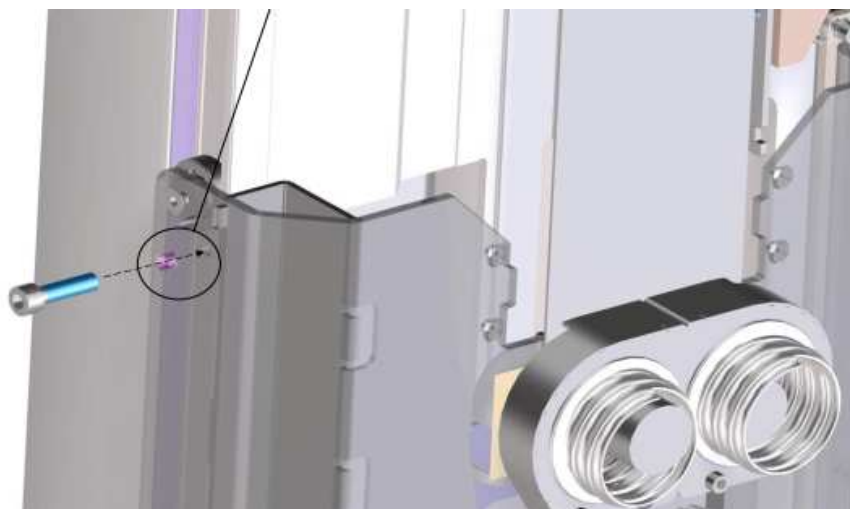
Remove the two screws fixing tube group  
And pull out the tube group

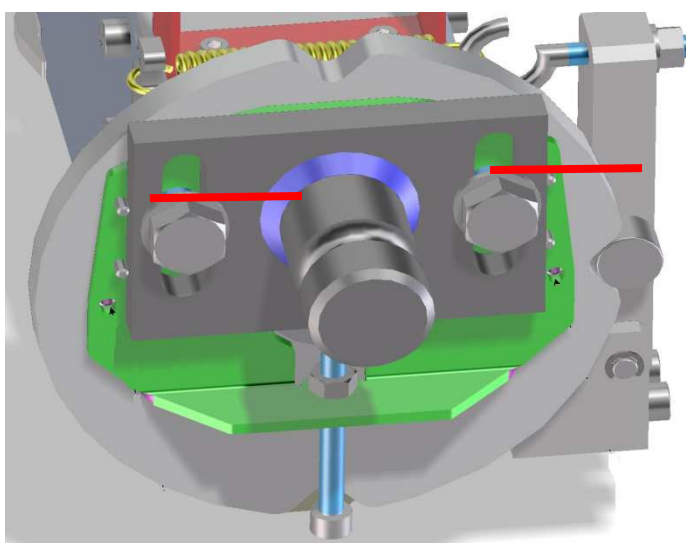
Take note of the pin actual position in order to put the new one in the same position

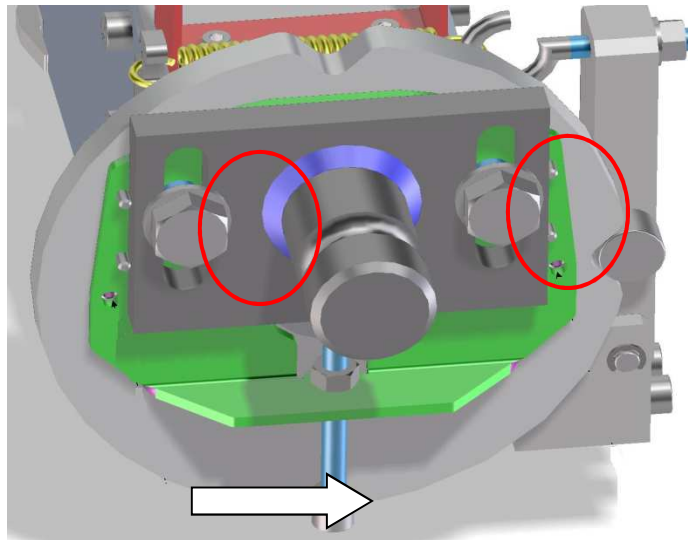
Loosen the lower screw and remove the rounded screws in order to remove the tube support pin

Replace the pin and mount the new one in the same position then tighten the positioning screw.
