FSN Ref: LUT-FSN-2023-001

## Field Safety Notice accucury

# Field Safety Notice (FSN) accucurv Thermal deformation of equipment

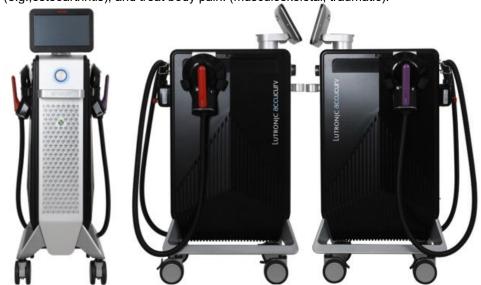
accucurv is an Electromagnetic Stimulator delivering magnetic field energy with its applicators. The applicator generates a magneticfield through the electrical energy delivered from the system and delivers it to the treatment location. accucurv Electromagnetic stimulator is indicated for patients with musculoskeletal and neurological painful disorder to treat musculoskeletal disorders (e.g., osteoarthritis); and treat body pain. (musculoskeletal, traumatic).

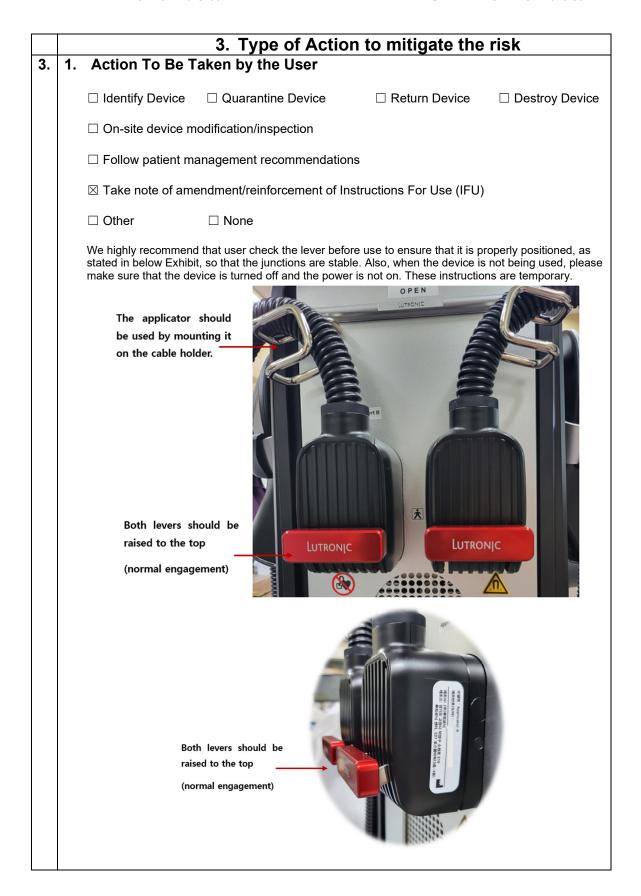
2 Reason for Field Safety Corrective Action (FSCA)				
2	Description of the product problem				
	The connection between the applicator and body may become loose due to external vibration,				
	shock or other factors. This loosening may cause heat generation.				
2	Hazard giving rise to the FSCA				
	The degree of heat may vary depending on the level of contact instability of the connector. This				
	instability could potentially lead to a rapid rise in temperature, causing a melt to the plastic cover.				
2	This may cause malfunction of the device or component failure.  3. Probability of problem arising				
_	Rare occurrence				
2	Predicted risk to patient/users				
	If a problem were to occur, it is unlikely that patient injury would occur because the user would				
	immediately recognize the abnormality. Also, if users are careful in their use, they should not				
	encounter any problems.				
2	<ol><li>Further information to help characterise the problem</li></ol>

If an abnormality is found in the applicator connection, stop using it and contact the manufacturer				
	immediately.				
2	Other information relevant to FSCA				
	We plan to upgrade and add additional parts to the lever, which will secure the junctions to be				
	appropriately placed, to prevent the loosening of connectors in all events and outside factors
