**Urgent Field Safety Notice**  
**Needle guide bushings for stereotactic breast biopsy**

**Urgent Field Safety Notice (FSN)**  
**Needle guide bushings for stereotactic breast biopsy**  
**may fail**

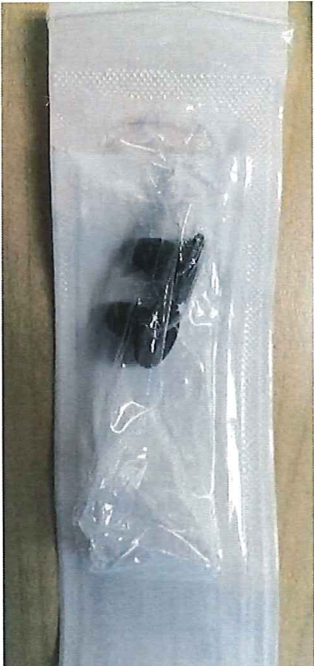
<p>Picture 1</p> </div> <div style="text-align: center;">

1. Information on Affected Devices*	
1	<p>1. <b>Device Type(s)*</b></p> <p>Sterile needle guide bushings for one-time use. These bushings are delivered sterile in pairs, i.e. one package includes two (2) bushings, according to picture 1. When using the stereotactic breast biopsy device, these bushings are used to guide the biopsy needle through the needle holder according to picture 2.</p> <div style="display: flex; justify-content: space-around; align-items: flex-end;"> <div style="text-align: center;">

<b>2 Reason for Field Safety Corrective Action (FSCA)*</b>	
<b>2</b>	<b>1. Description of the product problem*</b>
.	Some bushings have a material defect, which makes them brittle. The degree of this material defect varies. However, some of them, may break during normal usage in the field. This has happened and has consequently been reported.
<b>2</b>	<b>2. Hazard giving rise to the FSCA*</b>
.	When a bushing breaks, parts of it may fall on the breast, i.e. around the needle's entry into the breast. This may require the biopsy operator to clean the breast, remove the needle and replace the bushing. This could lead to extended surgery time and a potentially stressful situation for both patient and operator. No injuries have been reported due to this issue.
<b>2</b>	<b>3. Probability of problem arising</b>
.	N/A

3. Type of Action to mitigate the risk*		
3.	<b>1. Action To Be Taken by the User*</b>  <input type="checkbox"/> Identify Device <input type="checkbox"/> Quarantine Device <input type="checkbox"/> Return Device <input checked="" type="checkbox"/> Destroy Device  <input type="checkbox"/> On-site device modification/inspection  <input type="checkbox"/> Follow patient management recommendations  <input type="checkbox"/> Take note of amendment/reinforcement of Instructions For Use (IFU)  <input type="checkbox"/> Other <input type="checkbox"/> None  <p>If you have any of these bushings remaining, we strongly advise you, to stop using them. We will immediately and free of charge send you replacement bushings in stainless steel. For replacement please send an email to <a href="mailto:bushing@turonmedtech.com">bushing@turonmedtech.com</a> and you will get immediate respond with replacement instructions.</p> <p>Note that these stainless-steel bushings will be delivered nonsterile. A sterilization instruction will come with the bushings.</p>
