## **URGENT NOTICE MEDICAL DEVICE RECALL**

### **Drive DeVilbiss Healthcare Car Charger Power Cord Accessory (provided with the iGo®2 Portable Oxygen Concentrator)**

Isny, May 30th, 2025

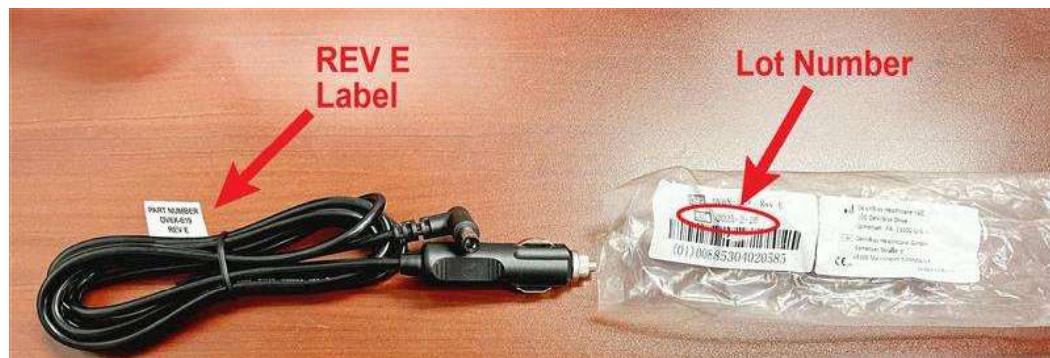
**Figure 1:** “Rev E” label and lot number placement

1. Identify any inventory in your possession using the following identifiers:
  - a. model DV6X-619 Rev E car charger cords of lot numbers 2023-01-01 through 2024-12-31 (see **Figure 1** below). Not all Rev E cords are recalled. Refer to step 1c below to confirm if the Rev E unit is recalled.

2. Destroy all affected car charger cords by cutting the cord with wire-cutters or unscrewing the cap and then discarding the car charger parts.
3. To obtain replacement car charger cords, click on the Verification Code hyperlink, located on the first page of this notice directly below the address block, or go to [www.recallrtr.com/iGo2DME](http://www.recallrtr.com/iGo2DME) and input the Verification Code. Using that code on the website, you will be able to:
  - a. Please confirm receipt of this recall and confirm the quantity of affected car charger cords in your possession (see **Table 1** on page 5 for the full range of affected lots and serial numbers)
  - b. Order replacement products; and
  - c. Fill out a web form to acknowledge receipt of and compliance with this recall.

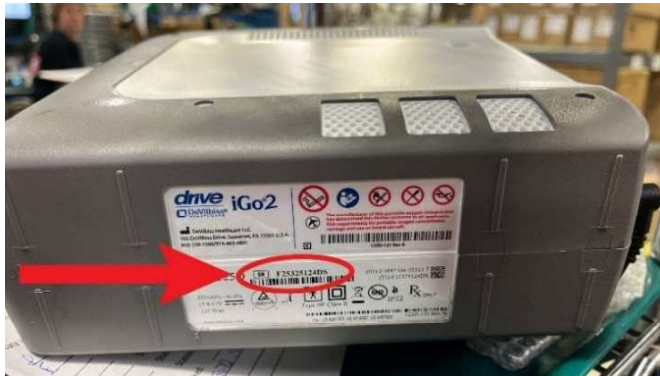
**Figure 2:** Serial number placement on iGo®2 POC Device

- b. If the cord that was originally included with the iGo®2 POC unit is still with the POC, the affected cords can also be identified by the serial number on the iGo®2 POC unit (see **Figure 2** below). The range of applicable serial numbers is provided in **Table 1** on page 5.

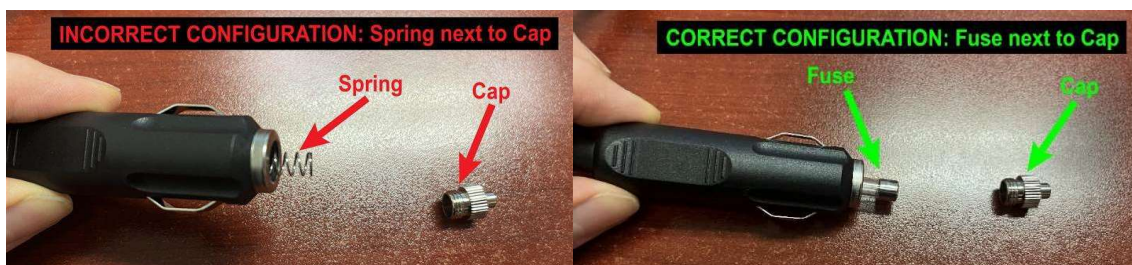
**Figure 3:** Inspecting the car charger cord adapter for spring or fuse position.

After receiving complaints related to overheating of the plug portion of the car charger cord, an investigation determined the root cause was an assembly error; specifically, the fuse and the retention spring were installed in the reverse positions. It was confirmed that during use, the adapter connection may become hot to the touch, and in some cases, cause deformation of the plastic housing. The manufacturing assembly error has now been corrected.

- c. If there is any doubt, or if you do not maintain the car charger cord with the original POC unit as part of your rental distribution process (i.e., used cords are stored and comingled in a box), inspection and confirmation of the condition of the car charger cord adapter can be easily performed by unscrewing the metal cap. (See **Figure 3** for spring and fuse position.)
- If it reveals the internal spring next to the cap, this configuration is being recalled.***
  - If it reveals the fuse next to the cap, this configuration is not recalled.***  
*Note: For every product confirmed to be unaffected by this recall, we recommend that you mark the label as acceptable in some permanent manner to ensure future inspections are unnecessary after rental redistribution and return.*
