URGENT FIELD SAFETY NOTICE

Product Name: **Alaris™ GS, GH, CC, TIVA, PK, Enteral Syringe Pump**

FSCA Identifier: **RA-2017-02-02**

Date: **March 2017**

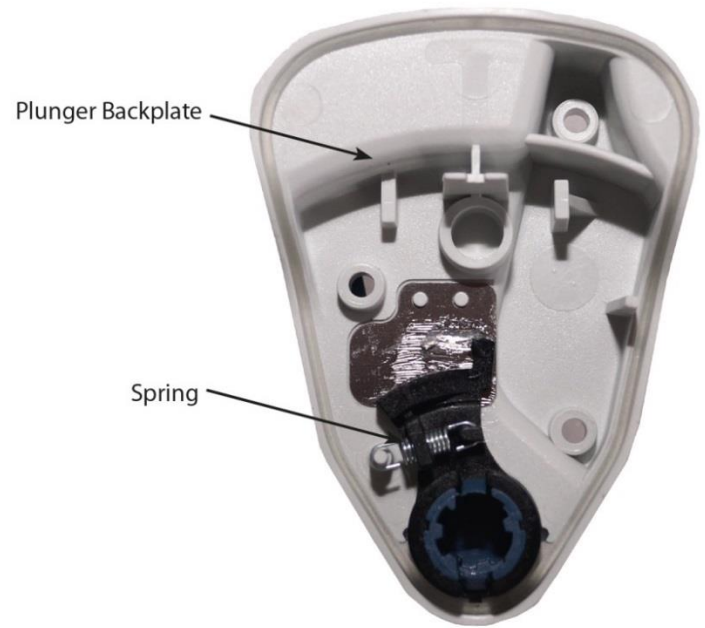
4. Remove the spring from the plunger backplate.
5. Fit a new spring to the plunger backplate.
6. Refit the plunger backplate.
7. Fit the three screws into the plunger backplate.
