**Urgent Field Safety Notice
 Important Medical Device Information**

Product Description:	Anaconda™ Longer Leg Iliac Stent Graft System (including Straight, Flared and Tapered configurations)
Catalogue Numbers	L12X160, L12X180, FL1213X150, FL1213X170, FL1215X150, FL1215X170, FL1217X150, FL1217X170, FL1219X150, FL1219X170, FL1221X150, FL1221X170, FL1223X150, FL1223X170, TL1210X150, TL1210X170
Lot/Serial Number	All Lots

Type of Action: Urgent Field Safety Notice (AN17-002)

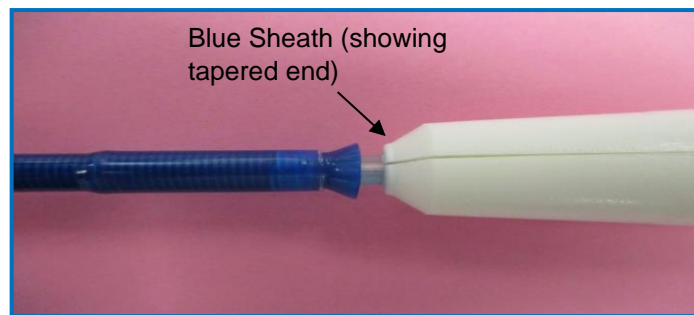
Figure 1a: Anaconda Longer Leg Delivery System (intact sheath prior to application of slider collar)

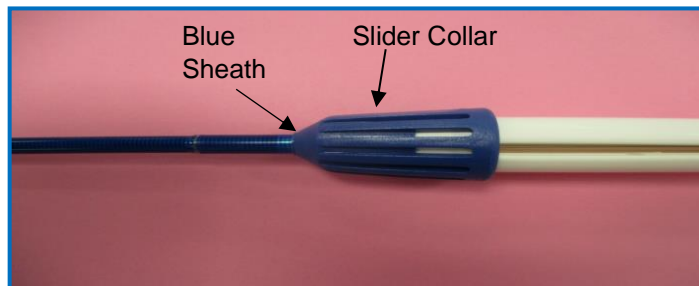
Figure 1b: Anaconda Longer Leg Delivery System (intact; showing position of blue sheath and slider collar)

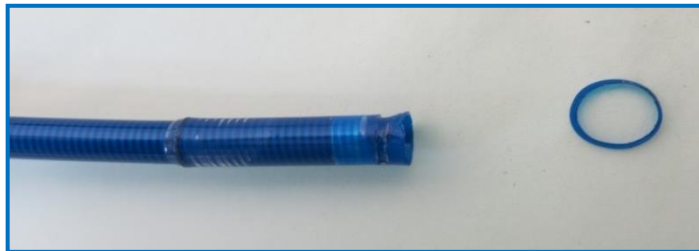
Vascutek Ltd. have received 2 complaints whereby the delivery system sheath became detached from the collar during the deployment of the Anaconda™ Longer Leg Iliac Leg Stent device from the Delivery System. Deployment of the stent graft was not affected. The root cause of this issue has been identified and rectified.

In both instances, a small section of the tapered end of the blue sheath became detached from the slider collar when the device was retracted (Figures 1a,1b and 1c). The appropriate bailout procedure outlined in the Instructions for Use (IFU) was utilised and the legs were deployed without incident or injury to the patient.

Figure 1c: Small section of the tapered end of the blue sheath detached from the slider collar following retraction of device

Vascutek Ltd. will not be taking any action with respect to product in the field as the severity of this risk is assessed as negligible. This is a mechanical failure of the device and poses no physical risk to the patient. The event rate associated with this issue is 0.1%.

Vascutek Ltd. advises that should this event occur during deployment of an Anaconda™ Longer Leg Iliac Stent Graft device, you should refer to the Anaconda™ Stent Graft System IFU for details of the bailout procedure.

Visualise via fluoroscopy if the stent has been partially unsheathed. If no unsheathing has occurred remove the delivery system and introduce a new delivery system.

If the graft has been partially unsheathed the following stages will fully unsheath the graft:

- 1. Retract the sheath slider until its blue tip is fully docked with the delivery system handle**
- 2. Carefully cut a central line through the outer sheath from the handle approximately 10 cm long**
- 3. Attach one set of forceps to each side of the sheath, ensuring the delivery system handle is stabilised.**
- 4. Retract the outer sheath carefully under fluoroscopy ensuring the sheath is split apart well away from the vessel, and that the sheath is split outside the arteriotomy to prevent any damage to the native vessel**
- 5. The sheath should be retracted until its distal end is in line with the blue tip of the fully retracted sheath slider. This will ensure that the graft is fully unsheathed.**
