URGENT - Field Safety Notification Medical Device Correction

Philips HeartStart MRx Monitor/Defibrillator on exceptionally rare occasions may exhibit abnormal behavior when operating using a single battery as the sole source of power.

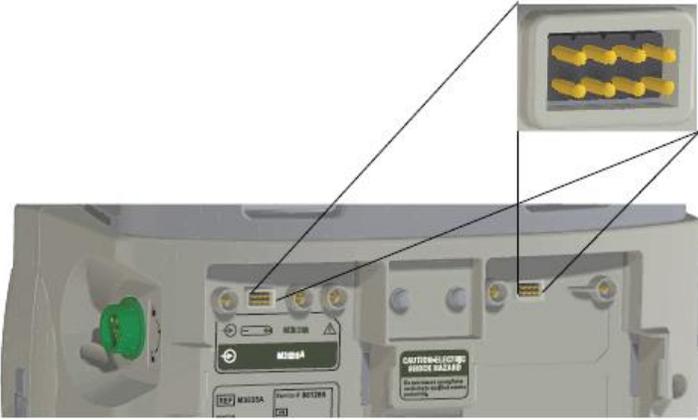
<p>BEHAVIOR DESCRIPTION 1</p>	<p>If the battery connecting pins (in the battery compartment of the HeartStart MRx Monitor/Defibrillator) become damaged or contaminated, it could result in a poor electrical connection that may cause the MRx to either (i) not power on or (ii) repetitively reboot, when used on battery power only.</p>
<p>HAZARD INVOLVED 1</p>	<p>HeartStart MRx Monitor/Defibrillator may, on exceptionally rare occasions, either (i) not power on or (ii) repetitively reboot. Either situation would make the device inoperative, delaying therapy to a patient in need of defibrillation, cardioversion, pacing, or monitoring.</p>
<p>ACTION TO BE TAKEN BY CUSTOMER / USER – 1</p>	<p>When inspecting the device, inspect the HeartStart MRx battery compartment connections. Include this step as part of a routine Operational Check to verify that the battery connector pins are clean, fully extended, not bent, and without residue.</p> <p>Figure A: Battery Connector Pins</p>

<p>Battery Connector pins, eight in each compartment</p>

<p>ACTIONS PLANNED BY PHILIPS - 1</p>	<p>Philips is voluntarily initiating this correction and is providing an Instructions for Use (IFU) Addendum entitled, <u>HeartStart MRx Battery Connector Pins</u>, for all customers with affected units.</p>

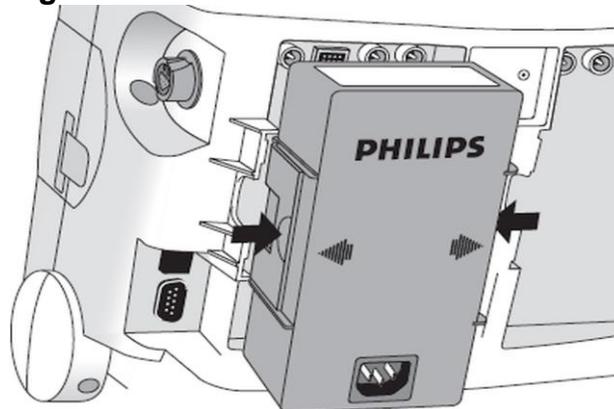
Figure C: AC Module Removal

- a. Remove the AC module from the MRx, rather than unplugging the cord from AC mains (see Figure C).

There are two ways to prevent this power switching. The user can either:
