Target

Identification of potentially affected sample probes for cobas c501/ cobas c502 and cobas c311

Identification of potentially affected sample probes for cobas c701/ cobas c702

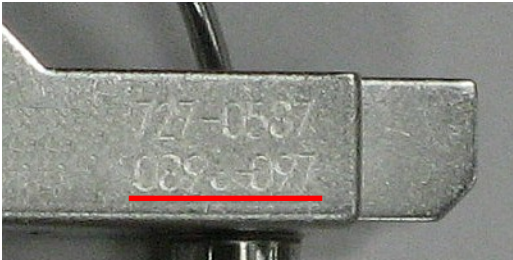
</div> <p>Either NAKA or OMUTA is indicated on the original package. Either Black or Green dot is marked on the sample probe.</p> <p>Black dot: Produced by NAKA Green dot: Produced by OMUTA</p>
Printed place on sample probe	<div style="display: flex; justify-content: space-around;">

</div> <p>Refer to Rule of printed serial number for detail.</p>

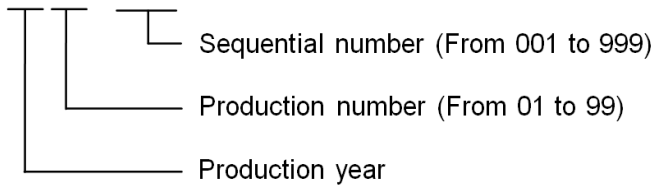
<p>Rule of printed serial number</p>	<p>727-0587 ← Part number YY AA – BBB ← Serial number</p>

<p>Sequential number (From 001 to 999) Production number (From 01 to 99) Production year</p> <p>Serial number printed on the probes for cobas c501/c502 and cobas c311 are making a common numbering by HHT's two production lines.</p>
<p>Place of yellow dot on the connector</p>

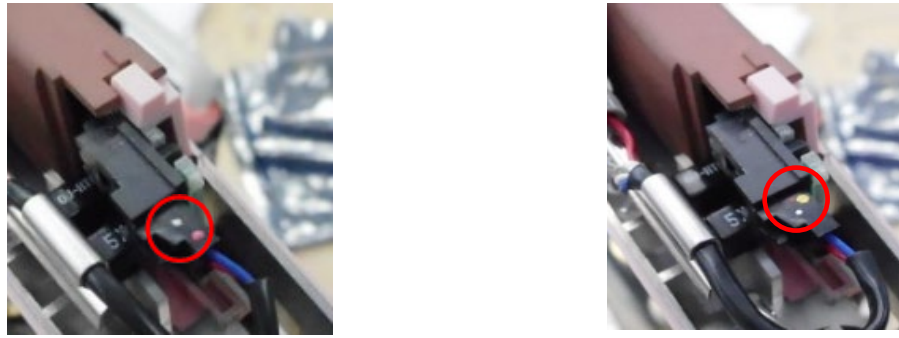
<p><u>No yellow dot mark</u> on the connector is affected. If the yellow mark on the connector is existed, the probe was modified done by HHT despite if the Serial number which printed on the probe was met.</p>
<p>SAP lot number which printed on the original package</p>

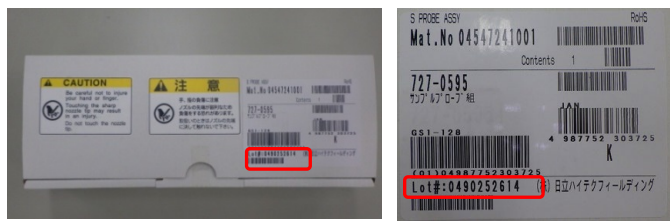
<p>Affected Sample Probe for cobas c311 (P/N 724-0920)</p>	<p>Lot number which indicated on the logistics label 0490232027, 0490233855, 0490236427, 0490238543, 0490241937, 0490248322, 0490250880, 0490235713, 0490252029, 0490256963</p>
<p>Affected Sample Probe for cobas c 501 and c502 (P/N 727-0595)</p>	<p>0490233762, 0490233764, 0490233766, 0490233767, 0490233777, 0490235904, 0490235905, 0490235906, 0490235907, 0490235949, 0490235950, 0490237594, 0490237595, 0490237353, 0490237354, 0490237597, 0490237598, 0490237600, 0490237602, 0490237604, 0490237606, 0490238955, 0490238957, 0490238893, 0490238895, 0490238896, 0490238898, 0490238899, 0490242149, 0490242151, 0490242153, 0490242155, 0490242327, 0490242328, 0490242329, 0490242330, 0490242331, 0490250491, 0490250492, 0490250493, 0490250494, 0490250495, 0490250496, 0490251032, 0490251033, 0490251034, 0490251036, 0490252524, 0490252527, 0490252529, 0490252532, 0490252247, 0490252249, 0490252251, 0490252252, 0490252272, 0490252398, 0490254550, 0490254551, 0490254552, 0490254553, 0490254554, 0490254555, 0490254804, 0490254805, 0490254806, 0490254807, 0490256999, 0490257000, 0490256993, 0490256994, 0490256995, 0490256996, 0490256997, 0490256998, 0490254808, 0490257001, 0490257847, 0490257848, 0490257849, 0490257850, 0490257851, 0490258652</p>

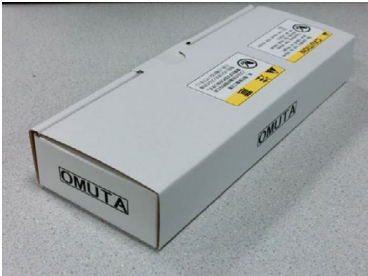
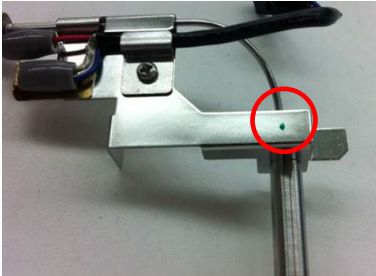
04945794001 SAMPLE PROBE (cobas c701/ cobas c702)	
Affected serial number which printed on the probe	ISE and Sample Probe for cobas c701/ cobas c702 do not have serial number printed on the probe itself.
Identification of production site in HHT

<p>Either NAKA or OMUTA is indicated on the original package. Either Black or Green dot is marked on the sample probe.</p> <p>Black dot : Produced by NAKA Green dot : Produced by OMUTA</p>
Place of yellow dot on the connector

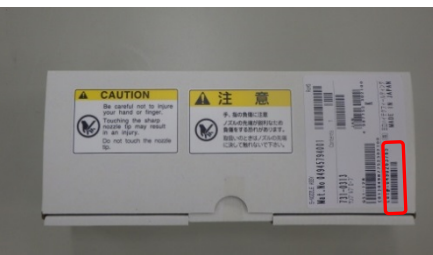
<p><u>No yellow dot mark on the connector is affected.</u> If the yellow mark on the connector is existed, the Sample Probe was already modified by HHT.</p>
SAP lot number which printed on the original package

<p>Refer to the separate attachment for detail of SAP lot numbers which printed on the original package.</p>

Affected Sample Probe for cobas c701/ cobas c702 (P/N 731-0313)	0490238960, 0490238961, 0490238961, 0490238961, 0490238963, 0490242332, 0490251040, 0490251041, 0490252546, 0490252547, 0490252547, 0490254810, 0490254811, 0490221658, 0490223228, 0490223229, 0490225255, 0490226172, 0490226173, 0490226174, 0490227626, 0490227627, 0490227628, 0490230276, 0490230277, 0490230279, 0490232203, 0490232204, 0490232205, 0490232206, 0490233778, 0490233779, 0490233780, 0490233781, 0490233783, 0490235909, 0490235910, 0490235911, 0490235912, 0490235913, 0490237365, 0490237366, 0490237367, 0490237368, 0490237369, 0490237370, 0490238901, 0490238902, 0490238903, 0490238904, 0490242160, 0490242161, 0490242163, 0490242165, 0490242166, 0490250498, 0490250499, 0490250500, 0490250501, 0490250502, 0490252308, 0490252312, 0490252318, 0490252320, 0490252322, 0490254558, 0490254559, 0490254560, 0490254561, 0490254562, 0490257035, 0490257036, 0490257037, 0490257038, 0490257039, 0490257854, 0490257855, 0490257856, 0490257857, 0490257858
