**FIELD SAFETY NOTICE**  
**for End-Customers using**  
**Hamilton Medical Ventilators HAMILTON-C1/T1/MR1**  
**Reference #: FSCA 2023-07-03**

**Failure description:**

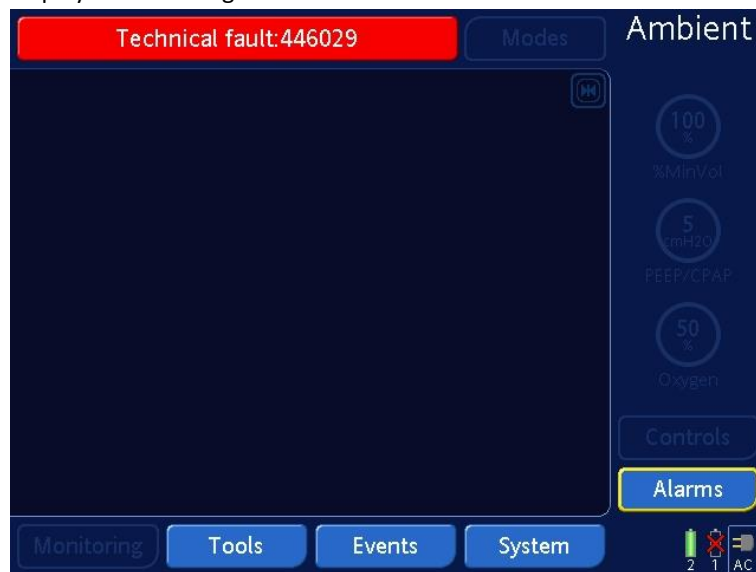
A degrading capacitor on the control board might leak electrolyte onto the control board, causing a short circuit on the board and/or the capacitor might lose its function. The primary function of this capacitor is to provide energy to store “Realtime Clock” information in case of total loss of power (external AC supply and battery) for example during storage.

As a result of the short circuit, affected HAMILTON-C1/T1/MR1 ventilators might switch to the “Ambient State”.

During the “Ambient State” the ventilator will alarm audibly and visually and display the following on the screen:

Figure 1: The display indicates “Ambient State”, and a red message with a Technical Fault number (example, a different Technical Fault number might be displayed)

**Required user actions if failure occurs:** In such a case, perform the following actions steps:

1. Provide alternative ventilation immediately.
2. You must switch off ventilator power to exit the “Ambient State”.
3. Once patient safety is ensured, it is required to have the ventilator serviced.

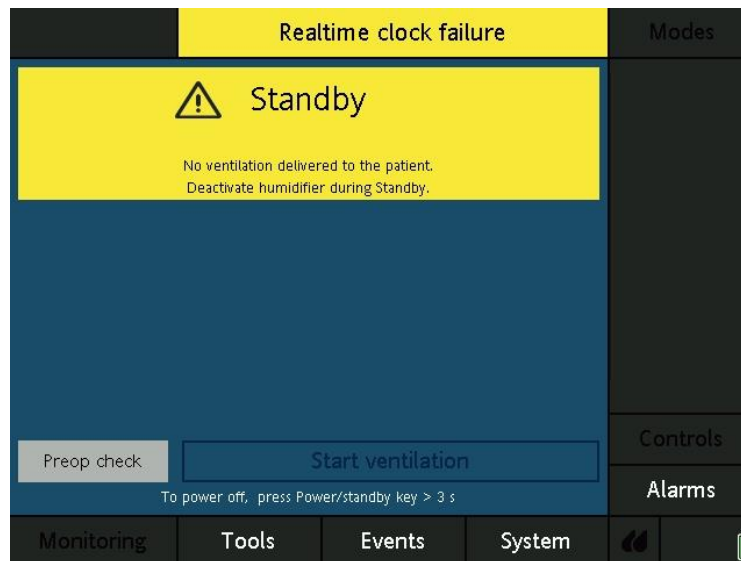
In case the “Realtime Clock” information is lost as a result of a degraded capacitor, the display will show a “Realtime clock failure” and the user will be notified to set date and time (see Figure 2). For further information see chapter “Setting date and time” in the respective Operator’s Manual.

Figure 2: Real Time Clock failure

A loss of “Realtime Clock” information does not have any severe consequence. This situation can only occur during startup of the ventilator. The “Realtime Clock” information needs to be set. Once date and time have been set by the user, the user needs to restart the device and ventilation can be started according to settings.
