To our customers of disposable breathing circuits/-sets

Important Safety Notice!!!

Possible hose short circuit

Only disposable breathing circuits on the attached list are affected

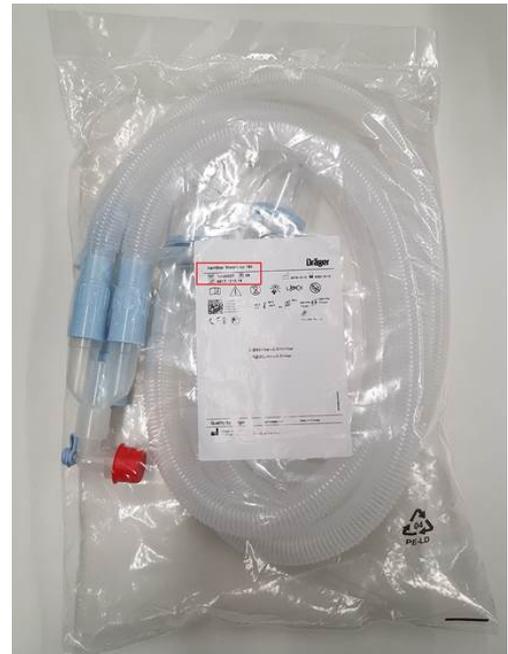
position of material number

According to our records, it is possible that breathing circuits that may be affected, i.e. that may have been incorrectly pre-assembled, were shipped to you during the past two years. We attach a list of material numbers that may be affected. The material numbers of the breathing circuits can be found on the respective packaging (see photo).

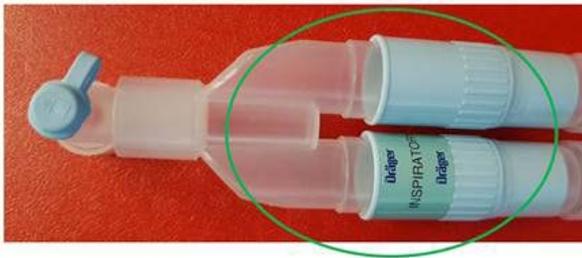
ok

Images showing correct “open ends” and incorrect “open ends” (test instructions):

Part Numbers: MP00337, MP00372, MP02720, MP02721, MP00334, MP00361, MP00362, MP00371, MP00374, MP00375, MP01682.

Before each use, and also after any temporary disconnection, please make sure to check whether the breathing circuit is assembled such that both the inspiratory and the expiratory connector of the ventilator or anesthesia machine are each connected to the y-piece.

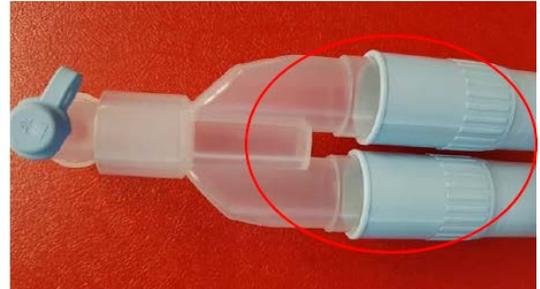
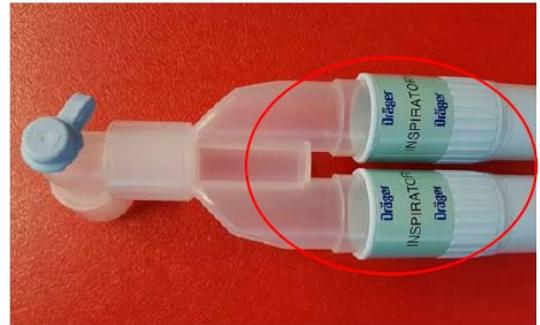
not ok

The correct set-up of the breathing circuit is illustrated in the Instructions for Use not only of the hose systems but also of the anesthesia machines and ventilators. Connection to the device must be checked prior to use. It is easy to detect if a breathing circuit has not been pre-assembled correctly because it will not be a single cohesive hose system but two separate sub-systems.

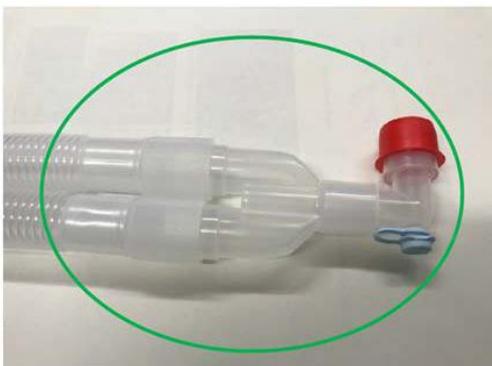
ok

Part Numbers: MP00349, MP00350, MP00351, MP00352, MP01326, MP01340, MP01341, MP01348, MP01350, MP00365, MP00366, MP01656, MP01657, MP01674, MP07933, MP07936, MP07937, MP07938, MP07955, MP07956, MP07981, MP07988, MP07989, MP07991, MP07992, MP07994, MP07996, MP07997.
