Important Medical Device advisory - Update

HeartMate 3™ Left Ventricular Assist System Catalog # 106524INT – HM3 LVAS KIT

May 22, 2018

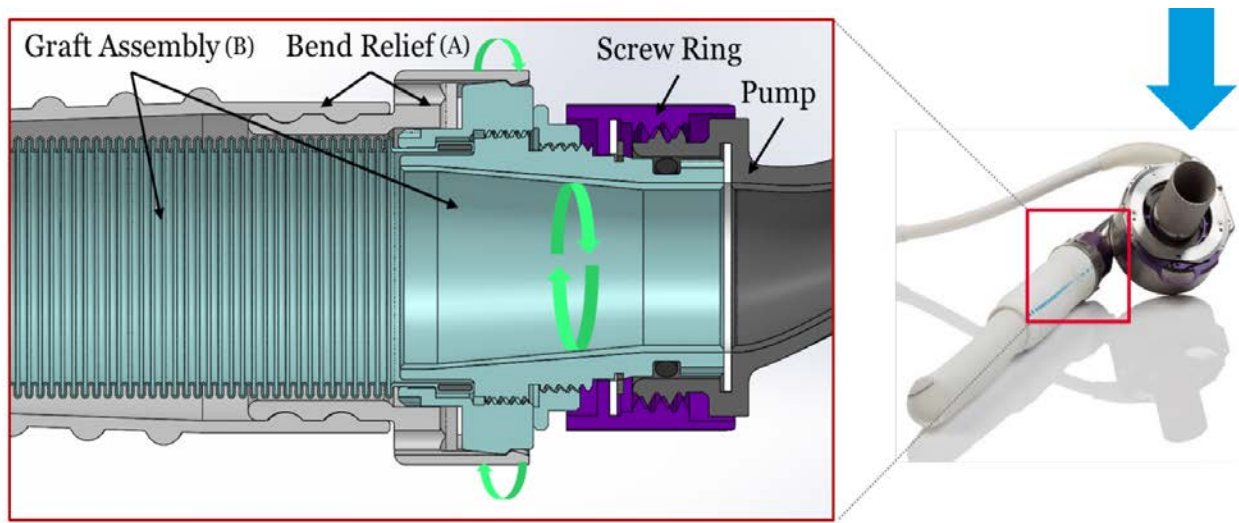
The HM3 is designed to allow for Outflow Graft connector rotation by the surgeon after connection to the pump, so that proper alignment of the Outflow Graft can be made during implantation without disconnecting the Outflow Graft connector from the pump. Appropriate tightening of the Screw Ring (see below) during implantation reduces, but does not eliminate, the propensity of the Outflow Graft connector to rotate. *In vivo*, normal forces can rotate the metallic Outflow Graft connector; if the rotation is in one direction only (instead of back-and-forth (clockwise/counter-clockwise)), then twist will accumulate in the graft. Accumulation of Outflow Graft twist can occur at any time point post-implantation. The twist may deform the Outflow Graft (a twist occlusion) and reduce or stop pump flow. The time course from the beginning of an accumulation of twist to an occlusion is unknown and may be variable among patients. Occlusion of the HM3 Outflow Graft often requires urgent surgical intervention.

During implant, when attaching the Outflow Graft to the Pump Cover, a clicking sound will be heard as the Screw Ring is tightened. Continue turning the Screw Ring clockwise until it comes to a complete stop and stops clicking. Firmly hand-tightening the Screw Ring may reduce the risk of Outflow Graft twisting by increasing the resistance to metallic Outflow Graft connector rotation. To avoid damaging the Outflow Graft assembly, do not use tools to tighten the screw ring. This updated information (see Appendix 1) will be incorporated into the Instructions for Use following regulatory approval in each geography.

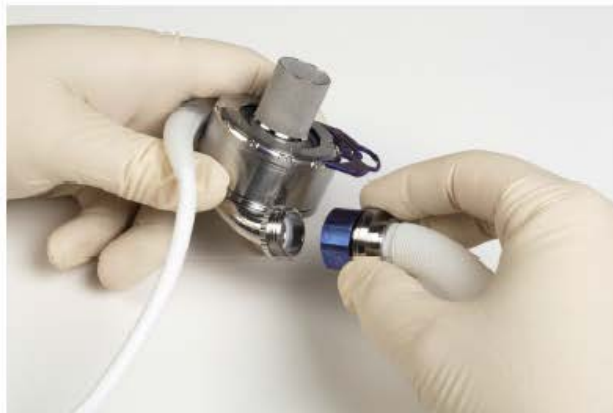
Figure 5.34 Attach the Graft

1. Remove the thread protector from the Pump and the Outflow Graft. Using the Screw Ring, attach the Outflow Graft to the Pump Cover, turning the ring clockwise. You will hear a clicking sound as you tighten the Screw Ring (this is normal). Continue turning the ring clockwise until it comes to a complete stop and stops clicking. See **Figure 5.34**.

2. Verify that the graft is not twisted or kinked by checking the position of the black line on the graft above and below the bend relief. The line should be straight.

Firmly hand-tighten the Screw Ring to ensure sufficient resistance to Outflow Graft twisting. To avoid damaging the assembly, do not use tools to tighten the Screw Ring.

- Firmly hand-tightening the Screw Ring may reduce the risk of Outflow Graft twisting by increasing the resistance to metallic Outflow Graft connector rotation. Hand-tightening will not eliminate metallic Outflow Graft connector rotation.
