October X, 2018
Olympus reference: QIL 151-006

URGENT FIELD SAFETY NOTICE

Olympus America received a complaint claiming that patients were infected after a bronchoscopy procedure in which a BF-1T180 bronchoscope with a loosened biopsy port was used. As a result of Olympus's investigation, it was discovered that the attachment of non-Olympus accessories to the bronchoscope's biopsy port may have resulted in more applied force than expected and lead to loosening of the biopsy port.

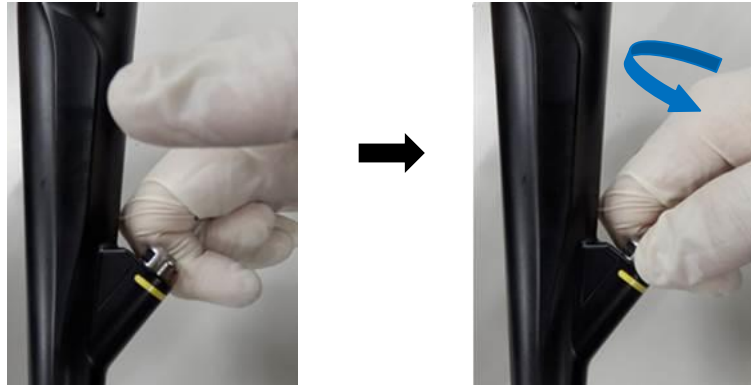
Picture 01: Counter-clock rotation

Wearing sterile gloves, attempt to rotate or turn the biopsy port in counter-clock direction as shown in picture 01. If the biopsy port is able to be rotated or turned, do not use the endoscope and return it to Olympus for repair. If the biopsy port does not rotate or turn, go to step 2.

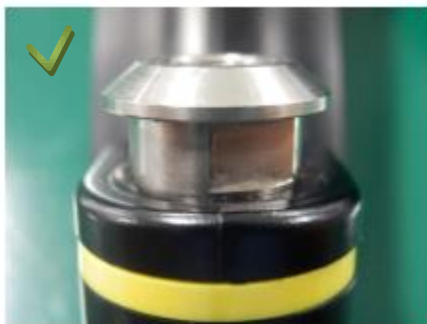
Picture 02: Normal Condition

Visually inspect the rubber part around the biopsy port of the referenced endoscope. If the rubber part is in a normal condition as shown in picture 02, the endoscope can be used in a patient procedure. If the rubber part is lifted from the molding parts as shown in picture 03, do not use the endoscope and return it to Olympus for repair.
